## → Aircraft Inspection Report

**BNP Paribas Leasing Solutions N.V.**

Aircraft Type: Mystere-Falcon

Aircraft Registration: PH-LCG

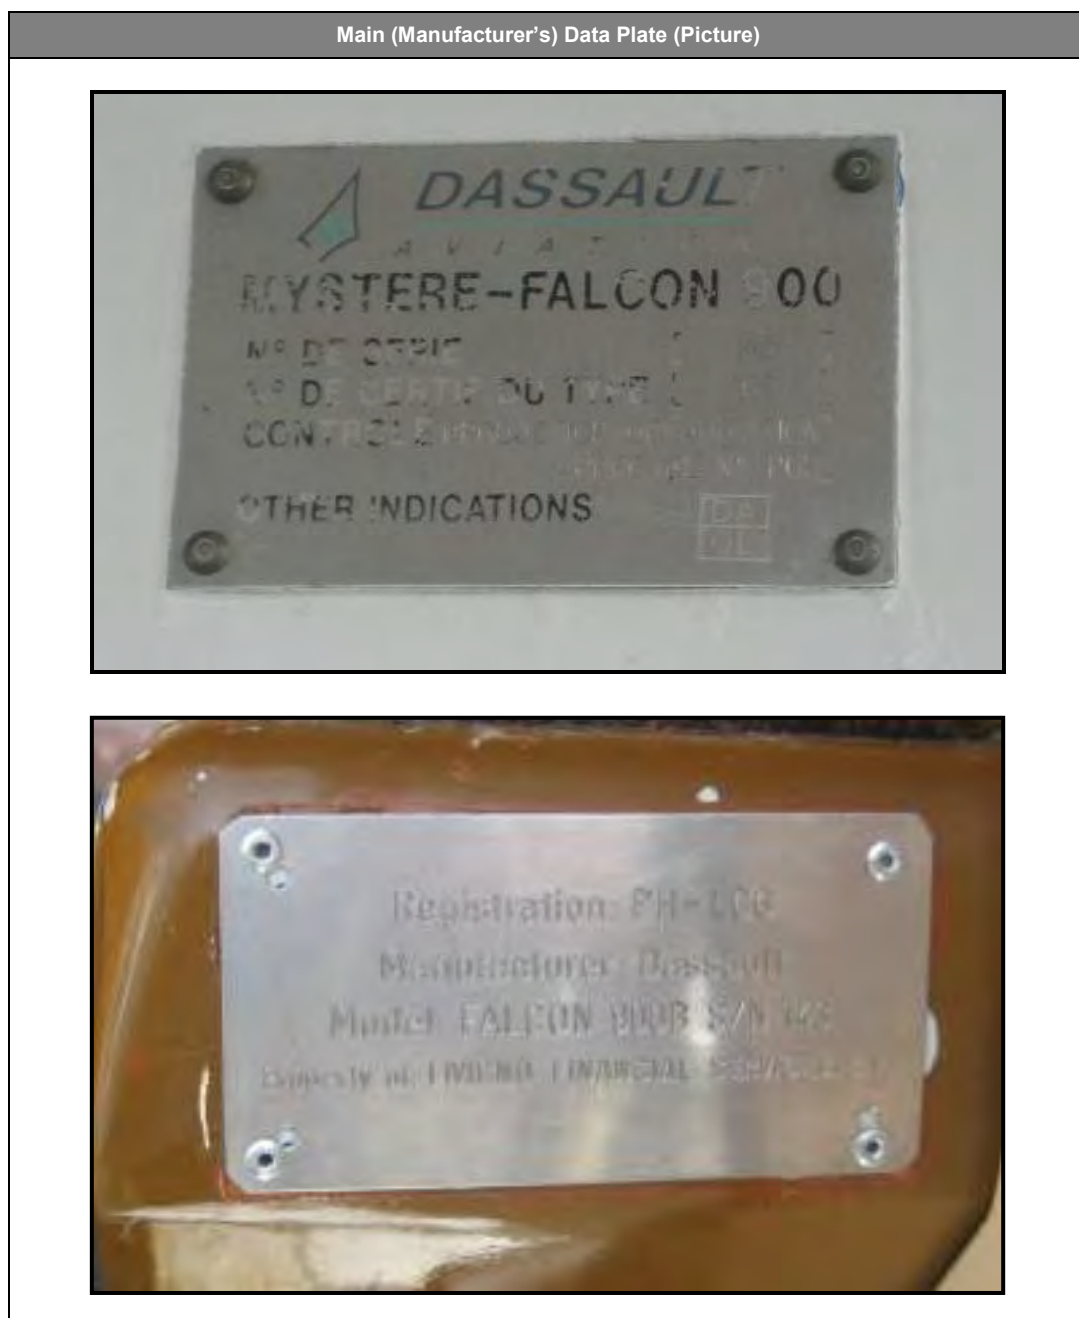
Main (Manufacturer's) Data Plate Information			
Manufacturer:	Dassault		
Type:	Mystere-Falcon	Model:	F900B
Date:	Illegible	Serial Number:	143

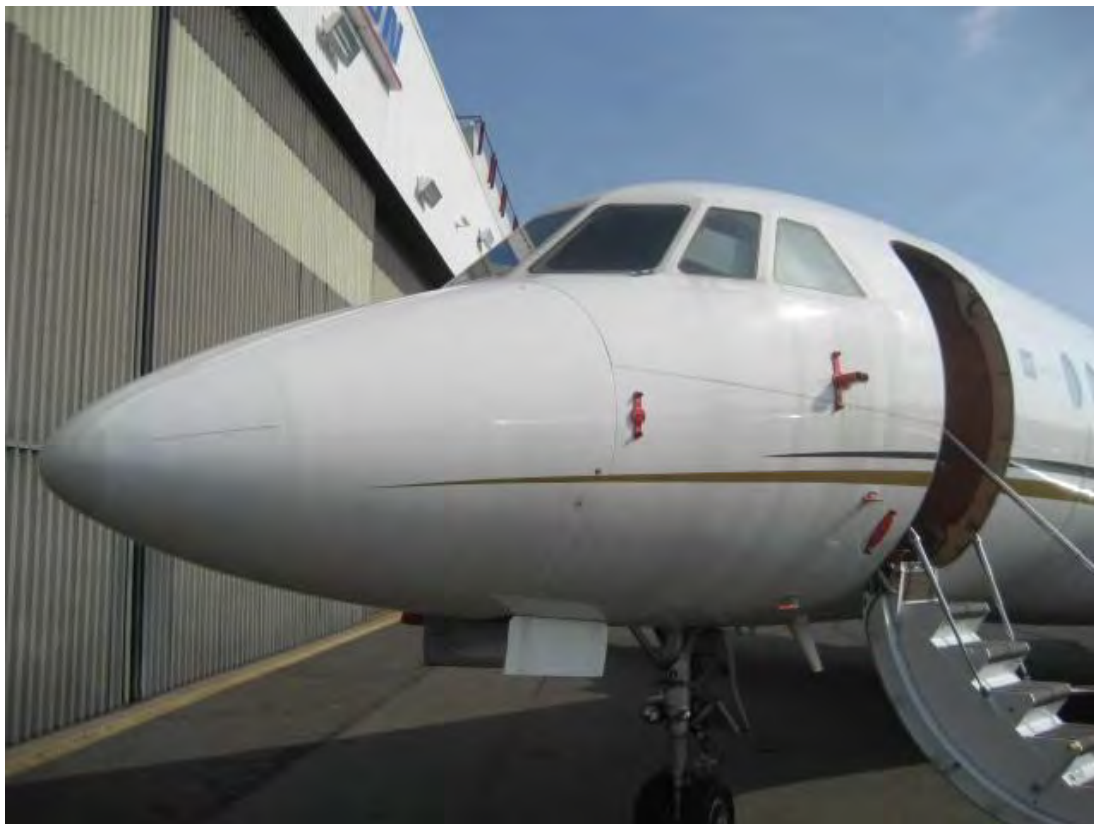
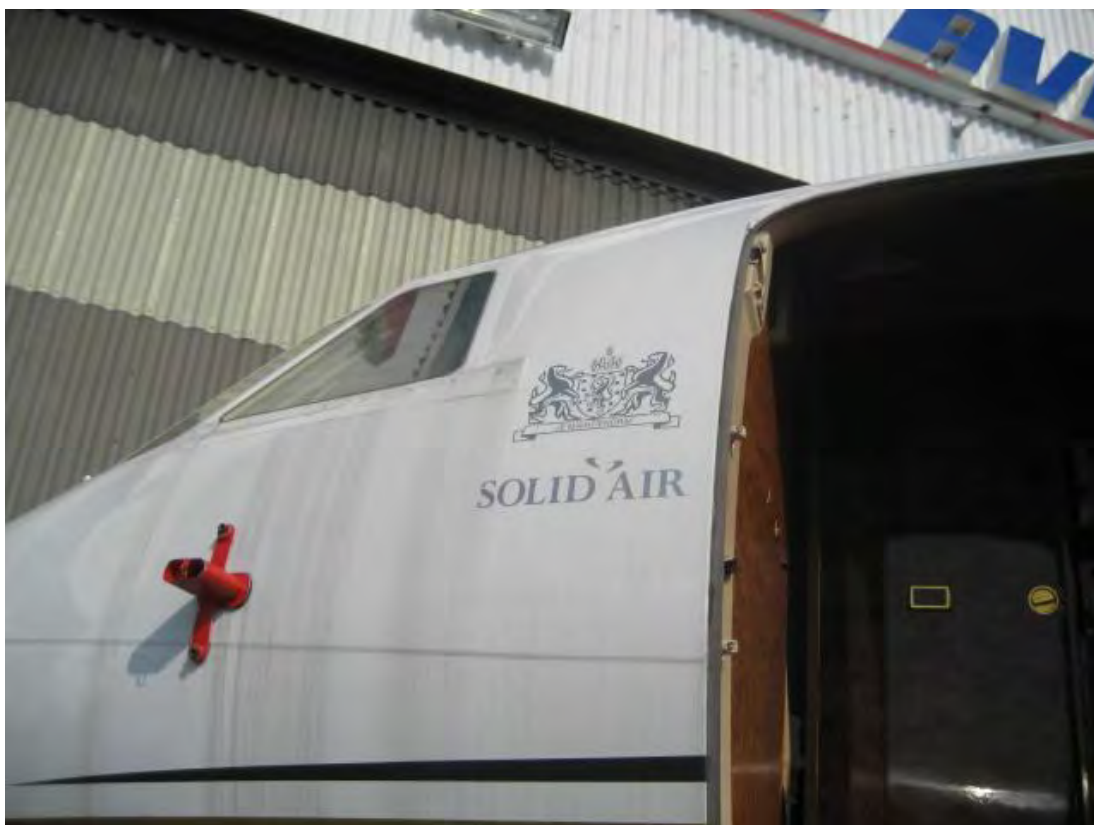
The Aircraft is very dirty and the paint has faded due to over-exposure to the sun

█ recommends deep cleaning the Aircraft and storing the Aircraft in a protected area if possible.

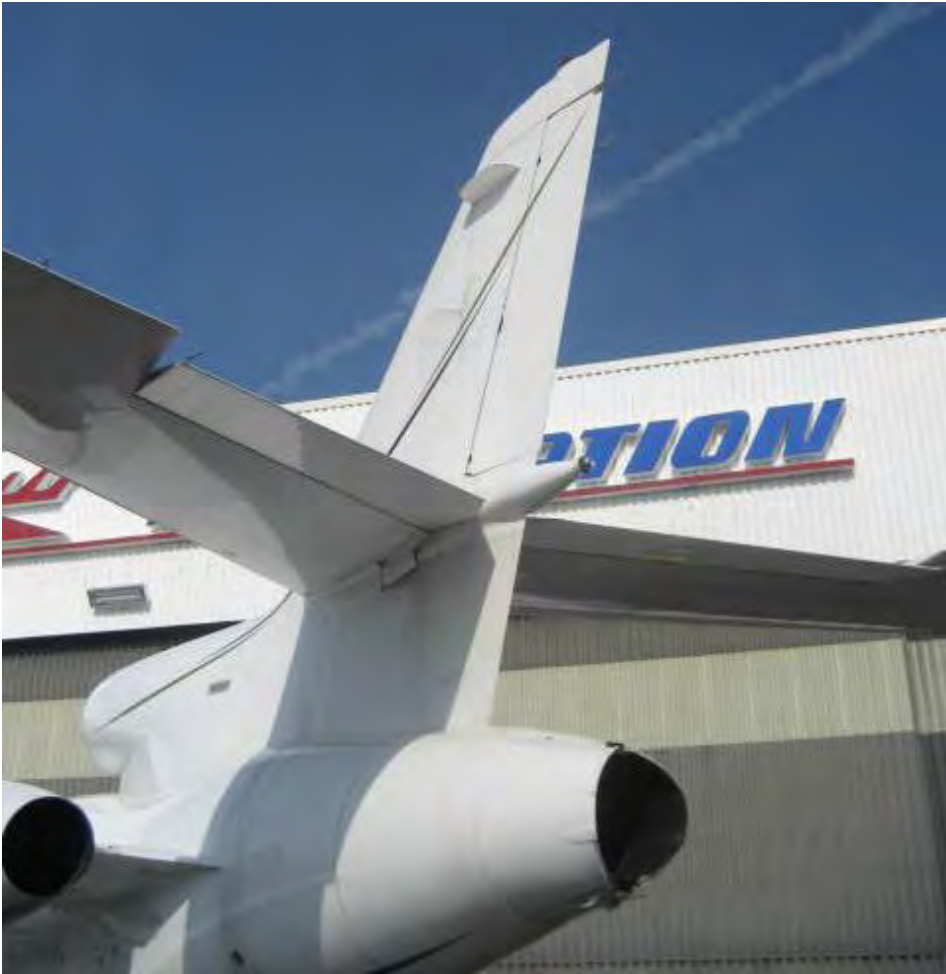
The paint is also in a poor condition due to having lost its gloss.

The static wicks are dry and oxidized.

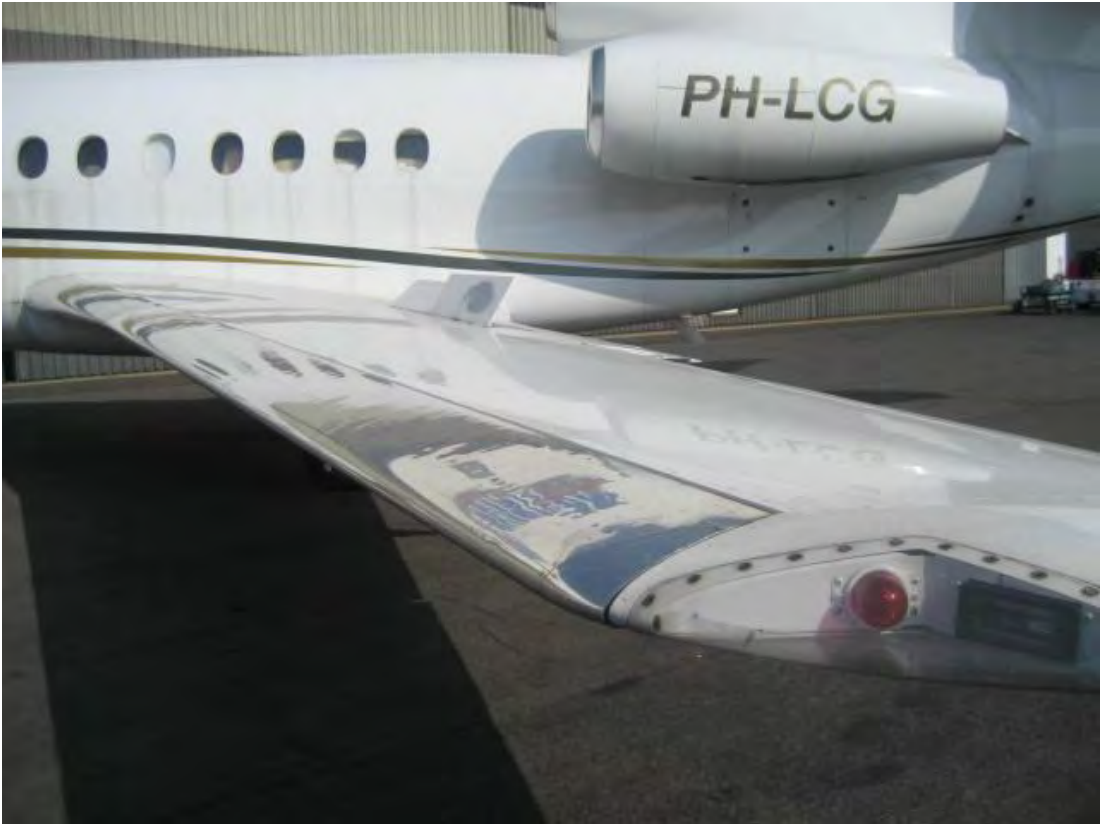
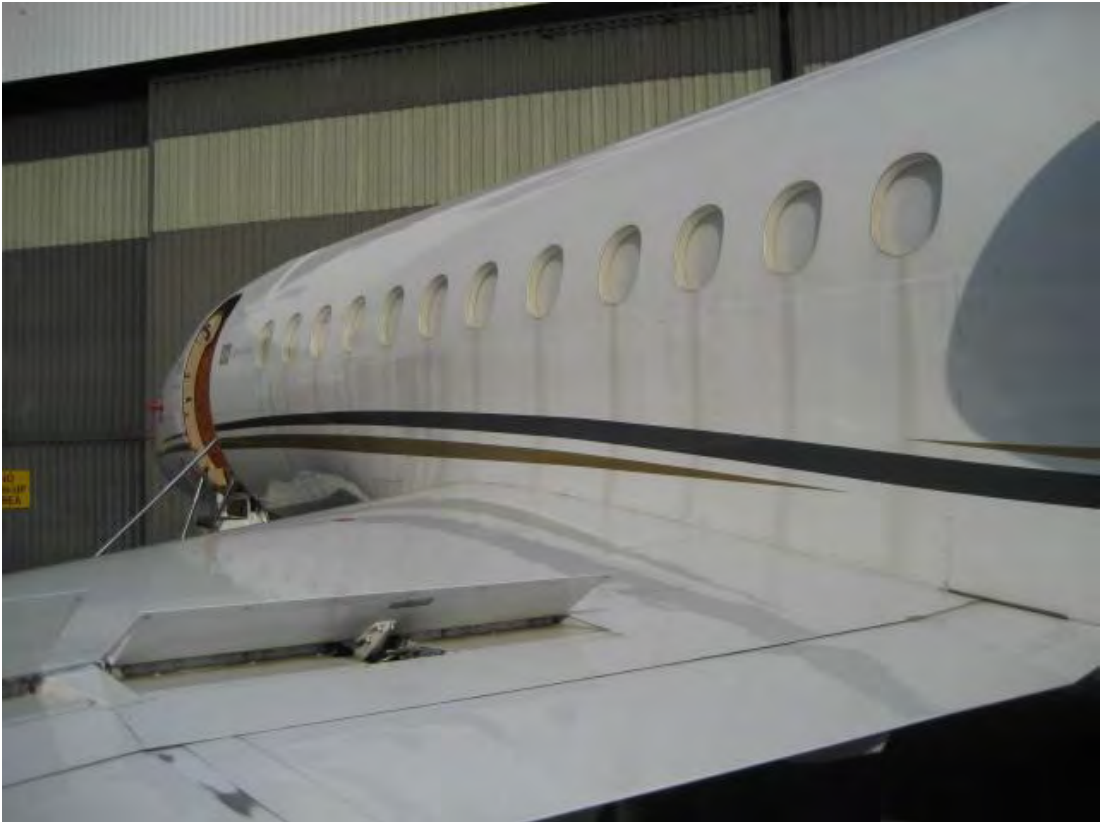
The wings are extremely dirty and over-exposed to sun

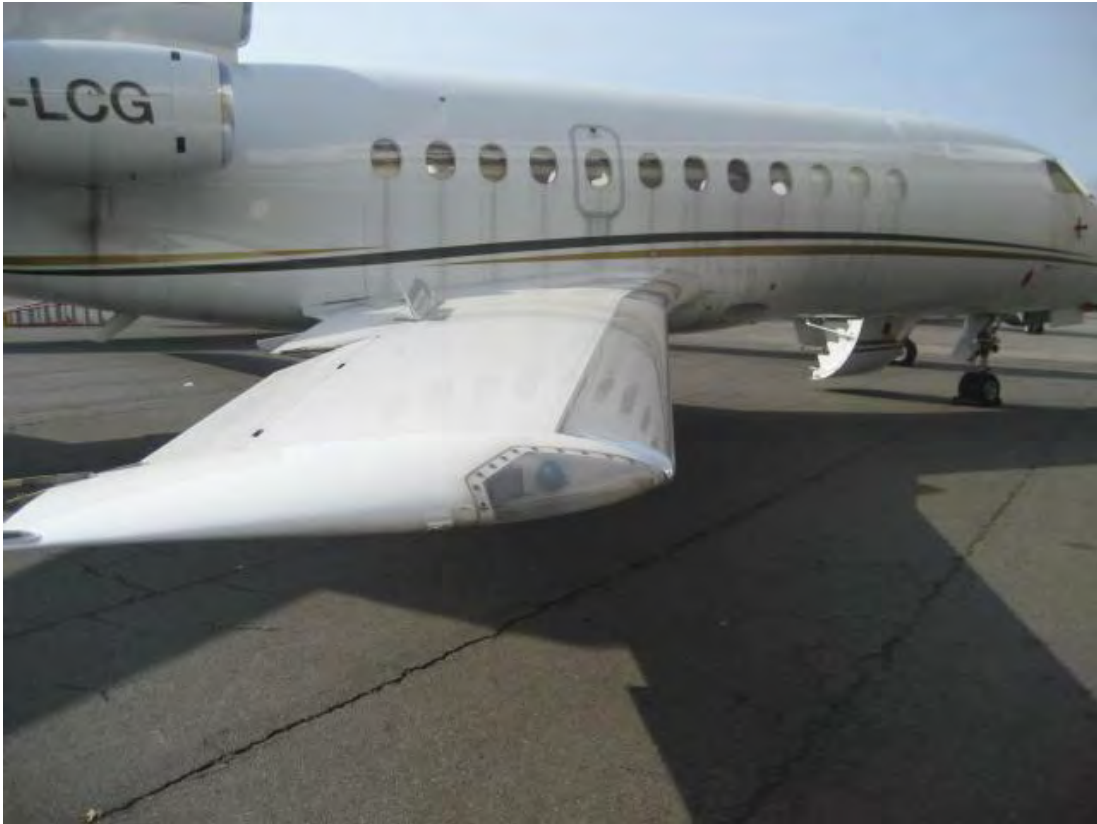
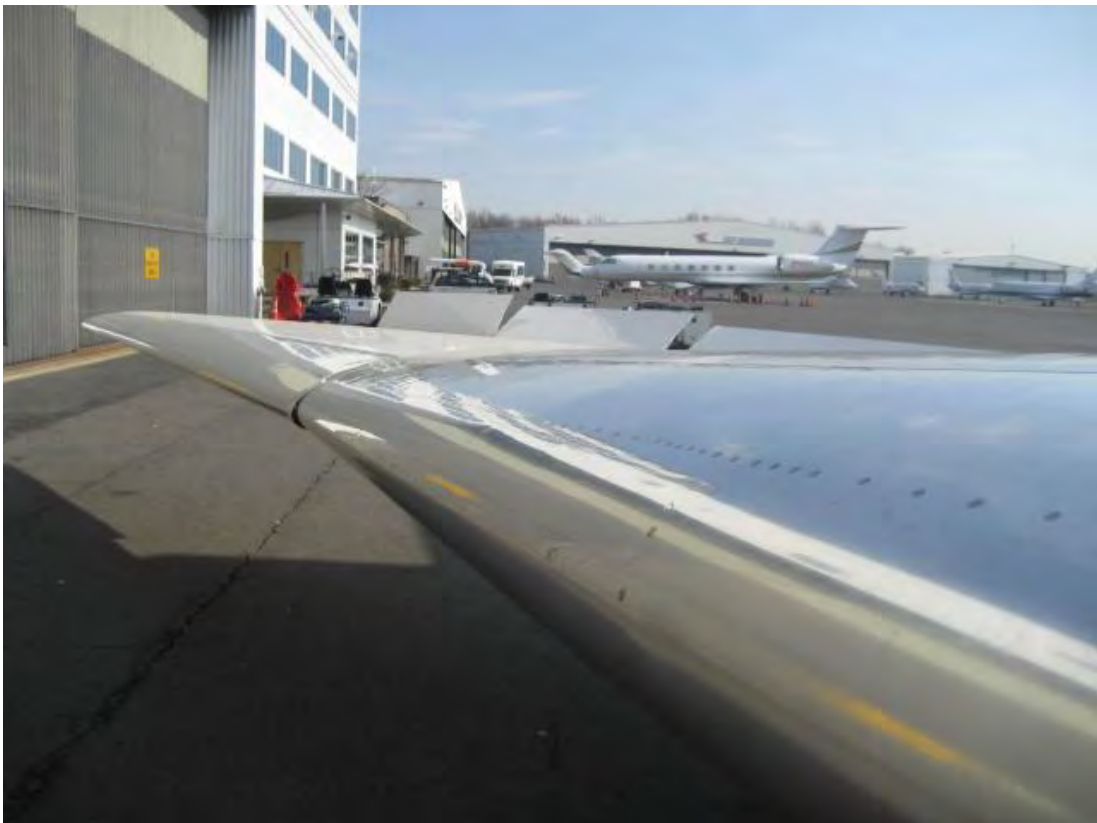
On the leading edges and devices extreme oxidation has been observed (see pictures).

On the leading edges and devices extreme oxidation has been observed

Areas which have been heavily oxidised should be polished and a detailed inspection of the engines and fuselage belly should be carried out to determine the extent of the corrosion. An inspection of the lavatory/galley plumbing should be carried out to see if it has ruptured due to freezing. The manufacturer will need to be contacted in order to find out how the aircraft can be brought back into an airworthy condition. However, before the manufacturer is contacted the missing documents need to either be obtained and reviewed or rebuilt.

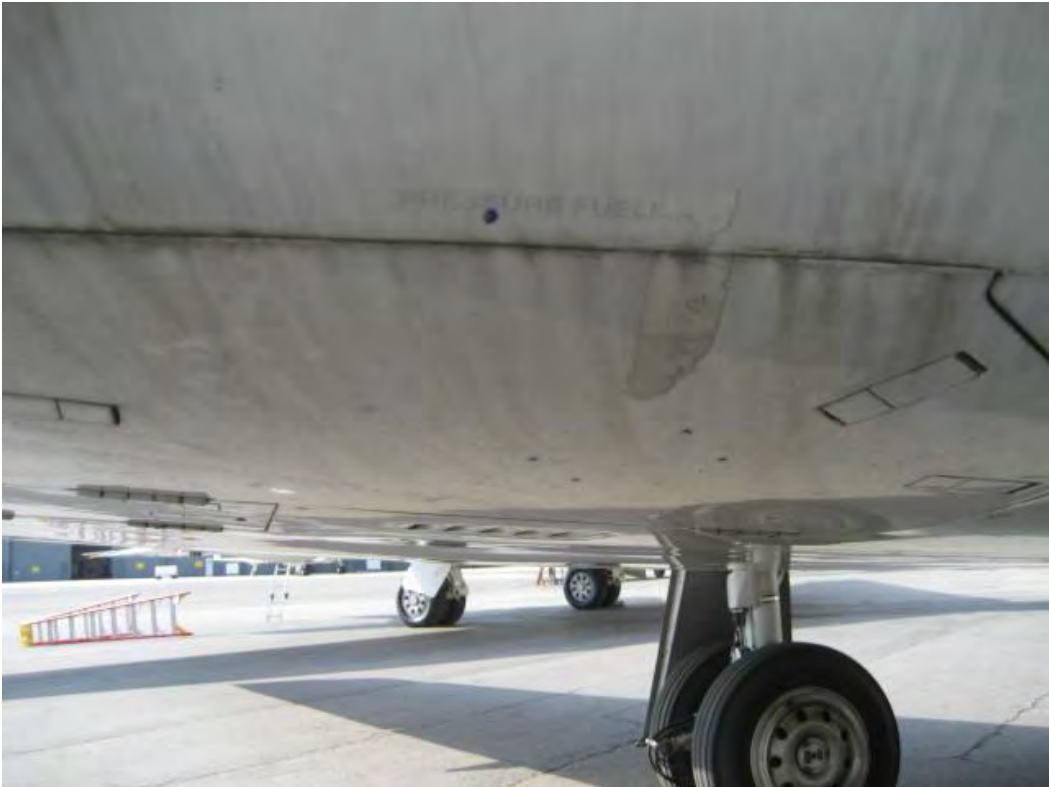
The right wing has evidence of a fuel leak and a hydraulic leak (see picture).

The right wing has evidence of a fuel leak and a hydraulic leak

- the fuel and hydraulic leaks on the right wing
- the shade on the emergency exit hatch
- refurbish the Captain's and First Officer's seat belts and the First Observer's seat

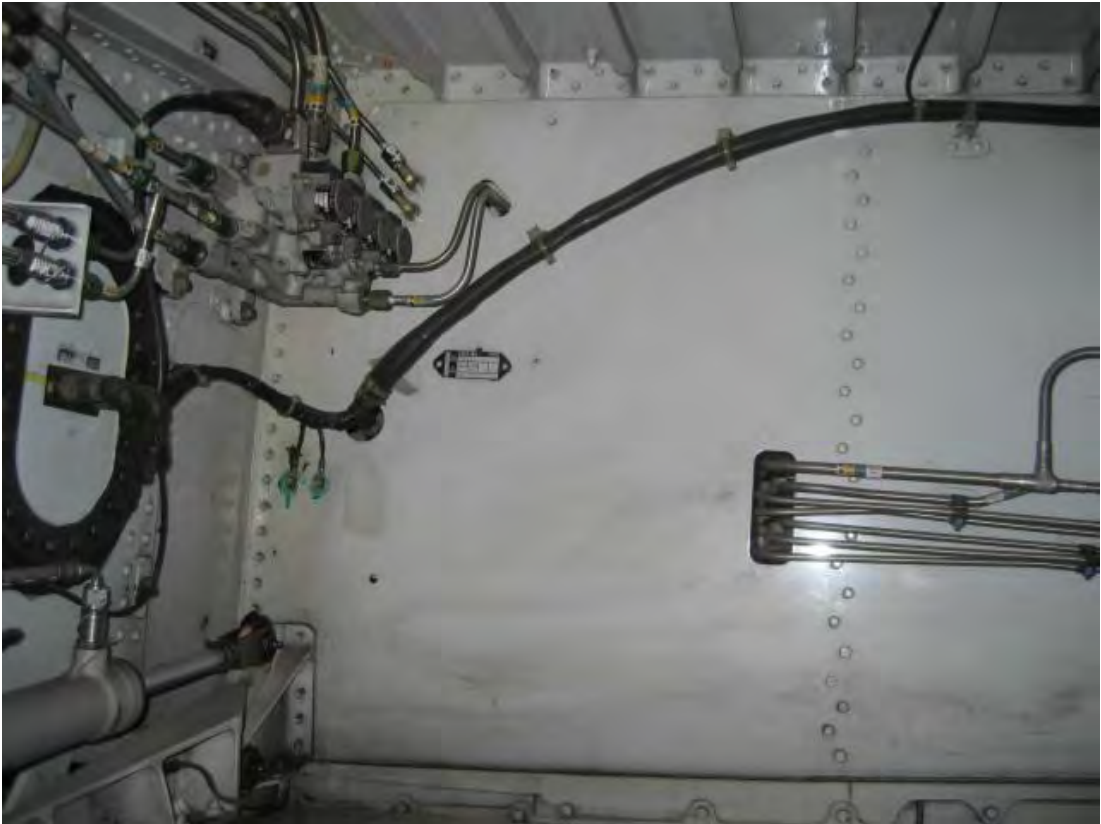
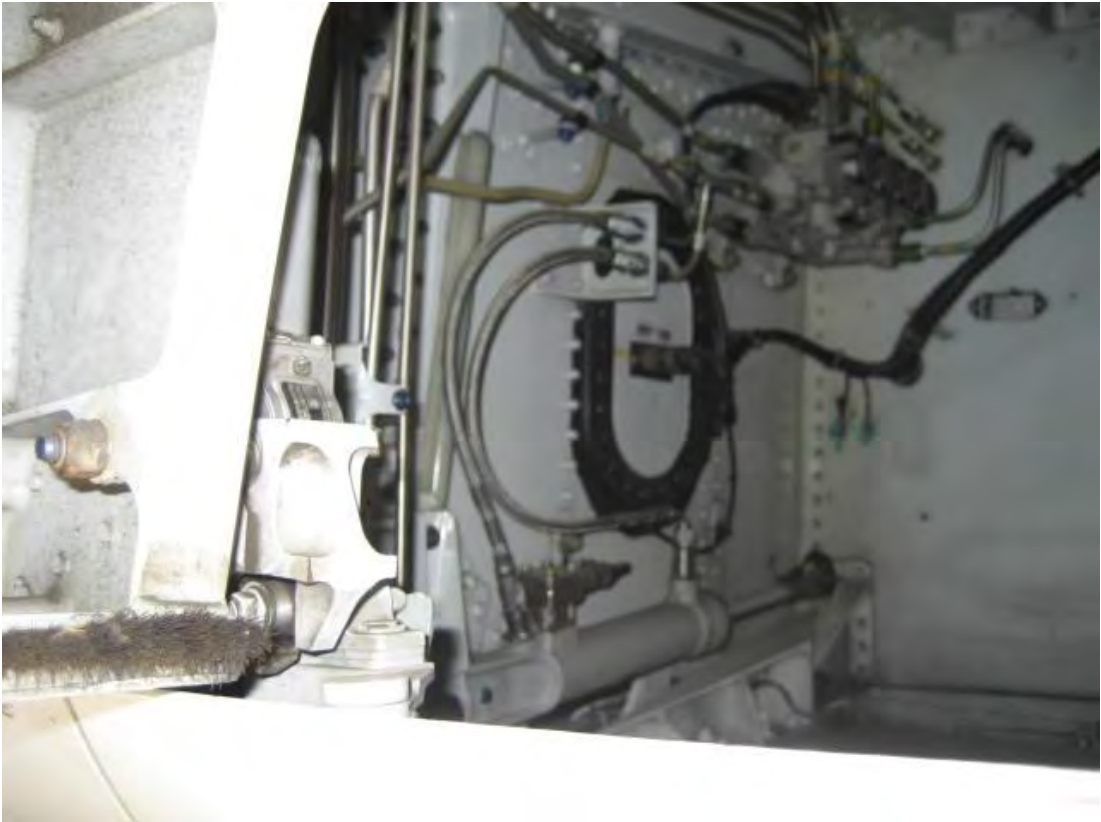
No corrosion prevention application has been observed. There is a high potential for significant corrosion given the Aircraft has been parked outside for 18 months.

Dirty internal structure

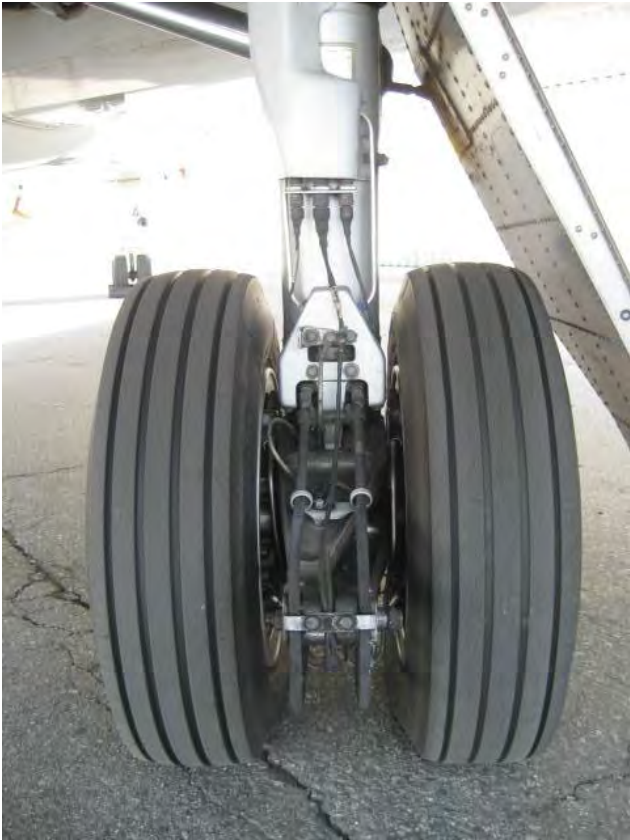
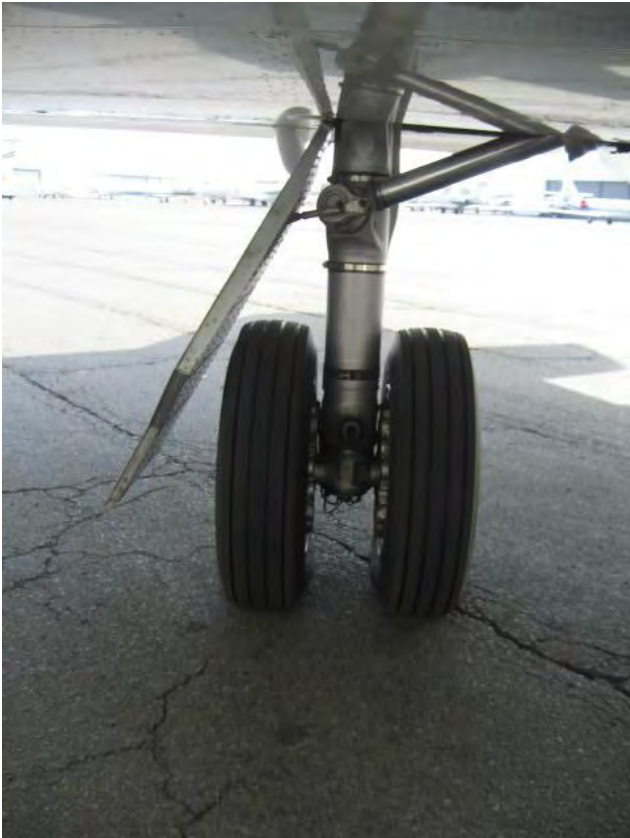
The R/H main landing gear and bay is in a generally AVERAGE condition.

The landing gear will require a complete lubrication and functional test prior to the next flight.

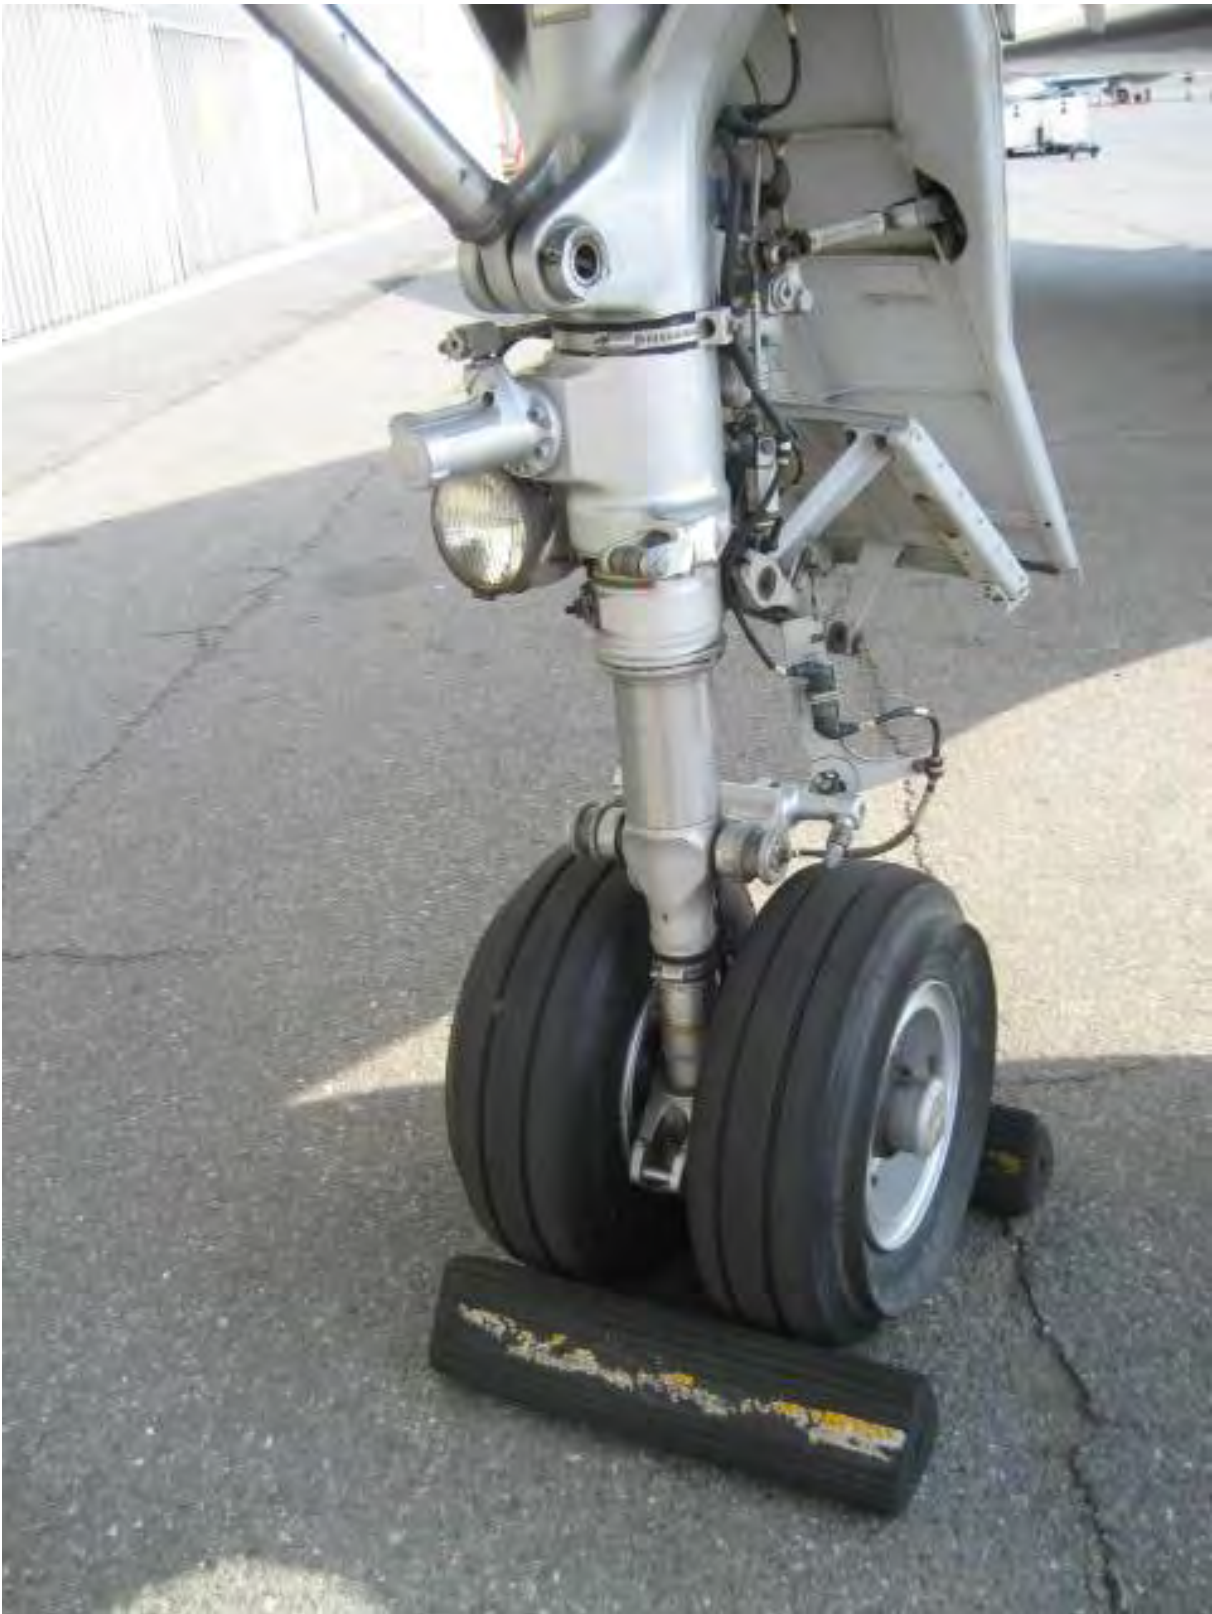
The nose landing gear area and bay is in a generally AVERAGE condition.

The landing gear will require a complete lubrication and functional test prior to the next flight.

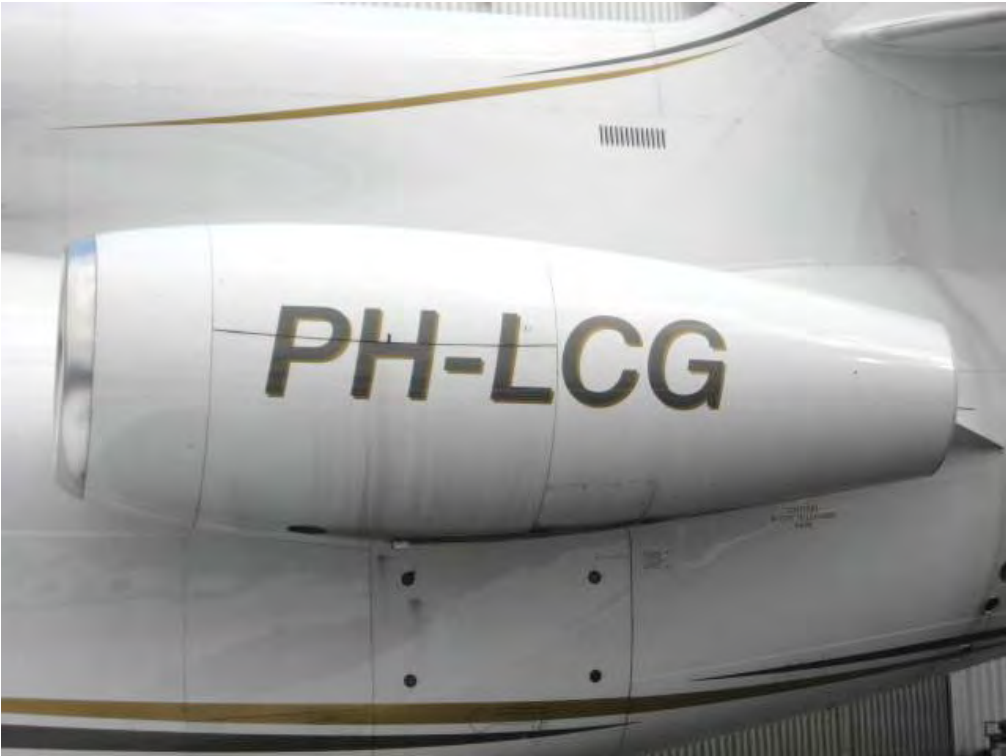
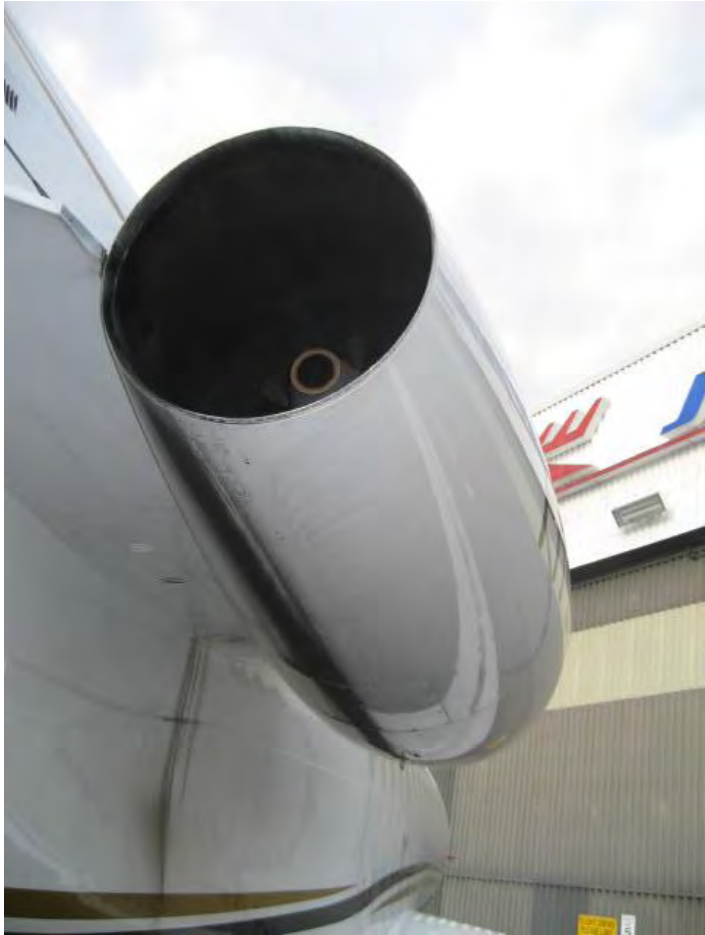
The general condition of Engine # 1 is in a POOR to AVERAGE condition.

There is high potential of corrosion and heavy oxidation on the inlet cowl.

The engine cowlings are very dirty.

Per Honeywell, none of the engines should be started. Honeywell requires the completion of a DERB Form (Damaged Engine Review Board – Used for Engine Accident/Incident Events or Preservation Issue Inspections) (Refer to Appendix 11) for each engine and the APU to investigate the condition of the engines to determine the next steps and requirements to return the engines to service.

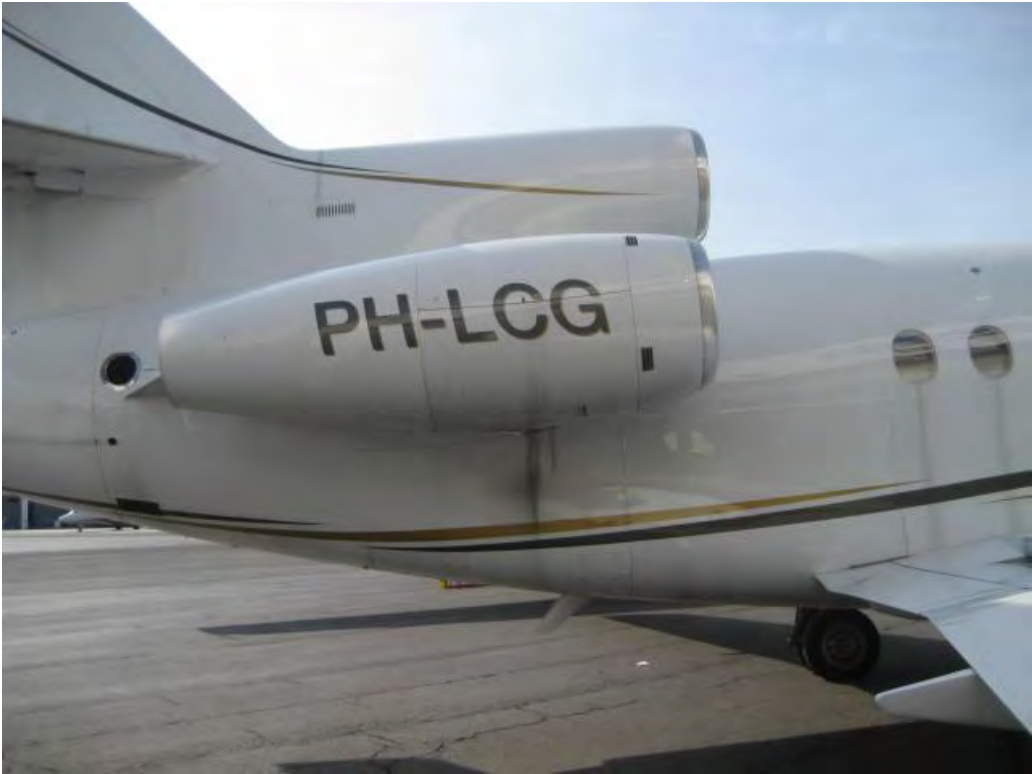
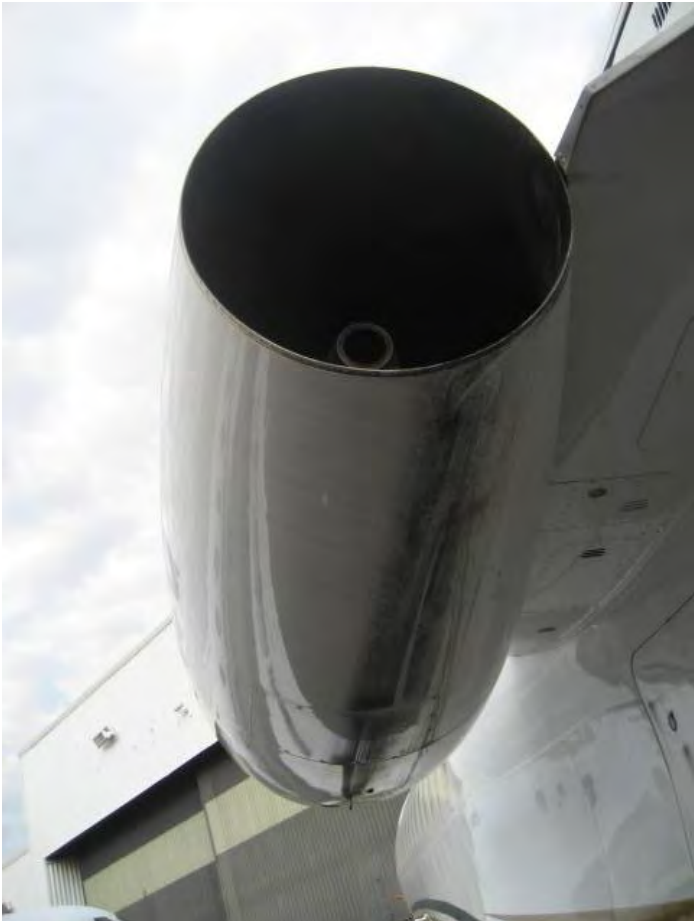
The general condition of Engine # 2 is in a POOR to AVERAGE condition.

There is high potential of corrosion and heavy oxidation on the inlet cowl.

The engine cowlings are very dirty.

Per Honeywell, none of the engines should be started. Honeywell requires the completion of a DERB Form (Damaged Engine Review Board – Used for Engine Accident/Incident Events or Preservation Issue Inspections) (Refer to Appendix 11) for each engine and the APU to investigate the condition of the engines to determine the next steps and requirements to return the engines to service.

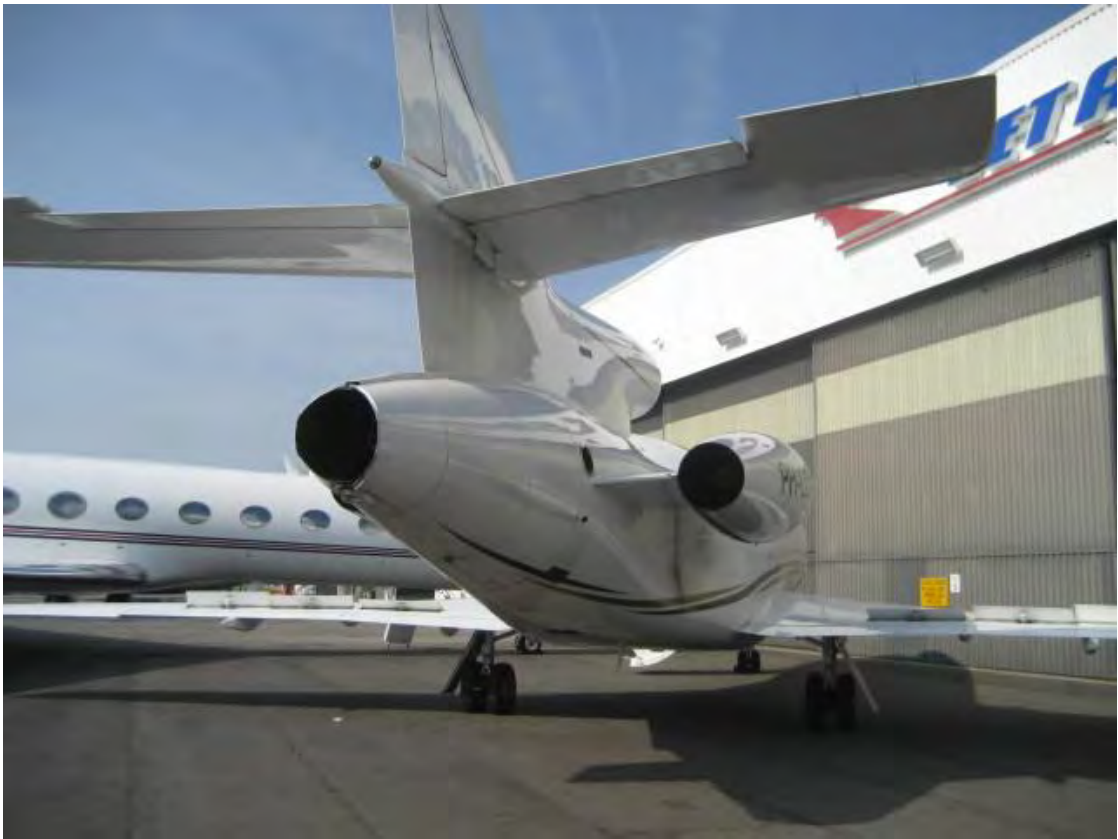
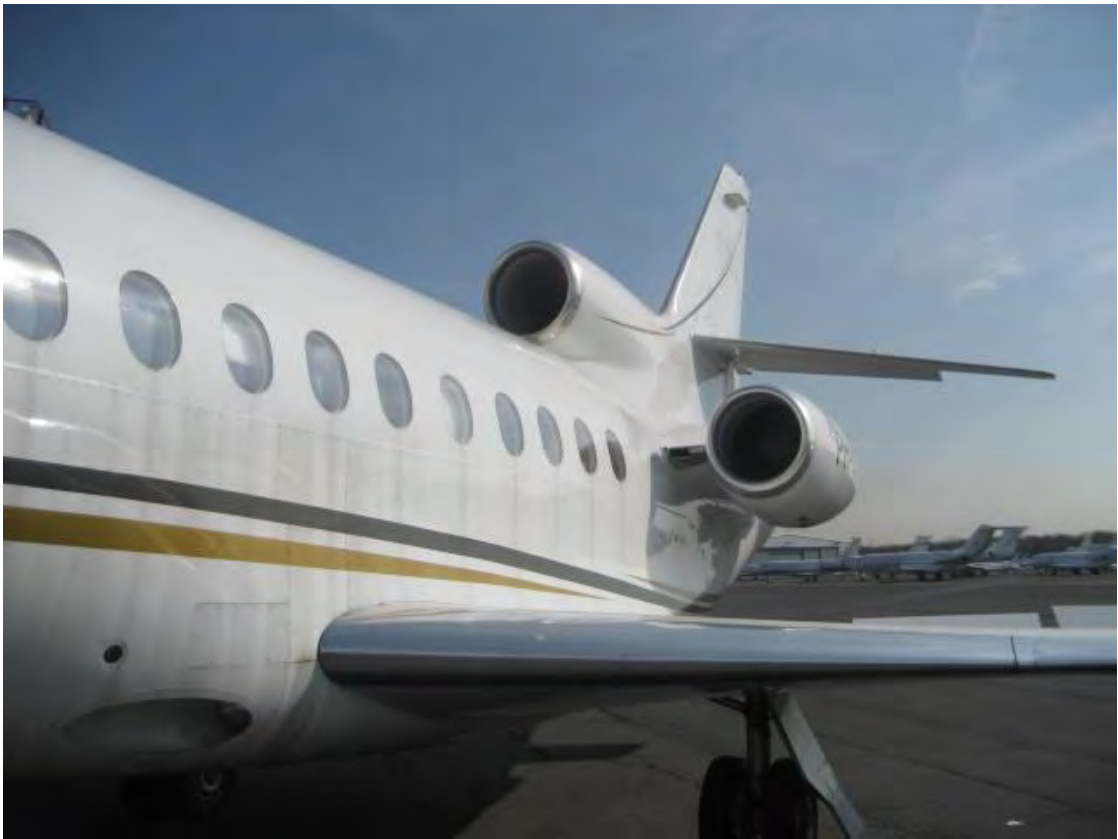
The general condition of Engine # 3 is in a POOR to AVERAGE condition.

There is high potential of corrosion and heavy oxidation on the inlet cowl.

The fan cowl doors and engine cowlings are very dirty.

Per Honeywell, none of the engines should be started. Honeywell requires the completion of a DERB Form (Damaged Engine Review Board – Used for Engine Accident/Incident Events or Preservation Issue Inspections) (Refer to Appendix 11) for each engine and the APU to investigate the condition of the engines to determine the next steps and requirements to return the engines to service.

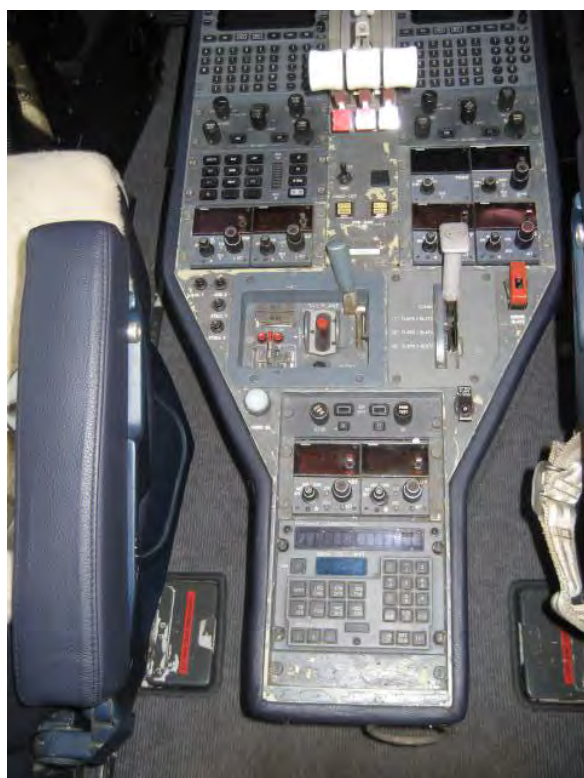
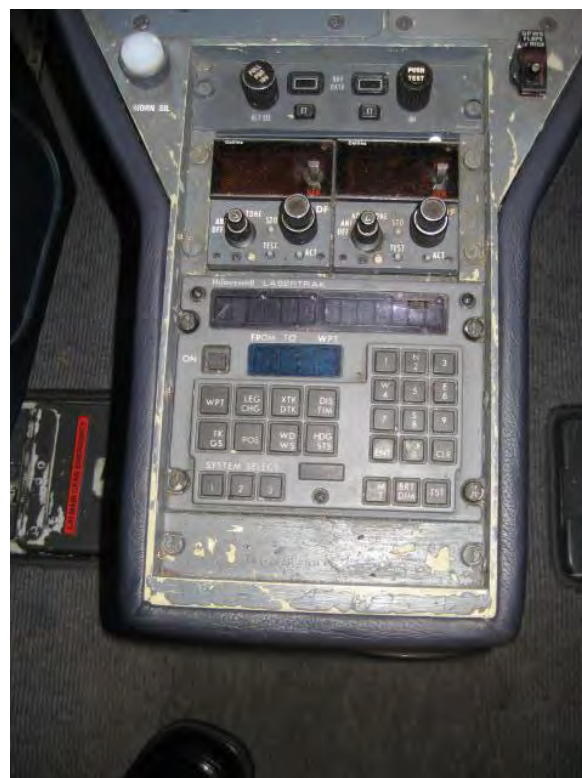
The instrument panels and placards and markings are old and worn. The centre pedestal has heavy nicks and scratches (see pictures).

Damaged centre pedestal

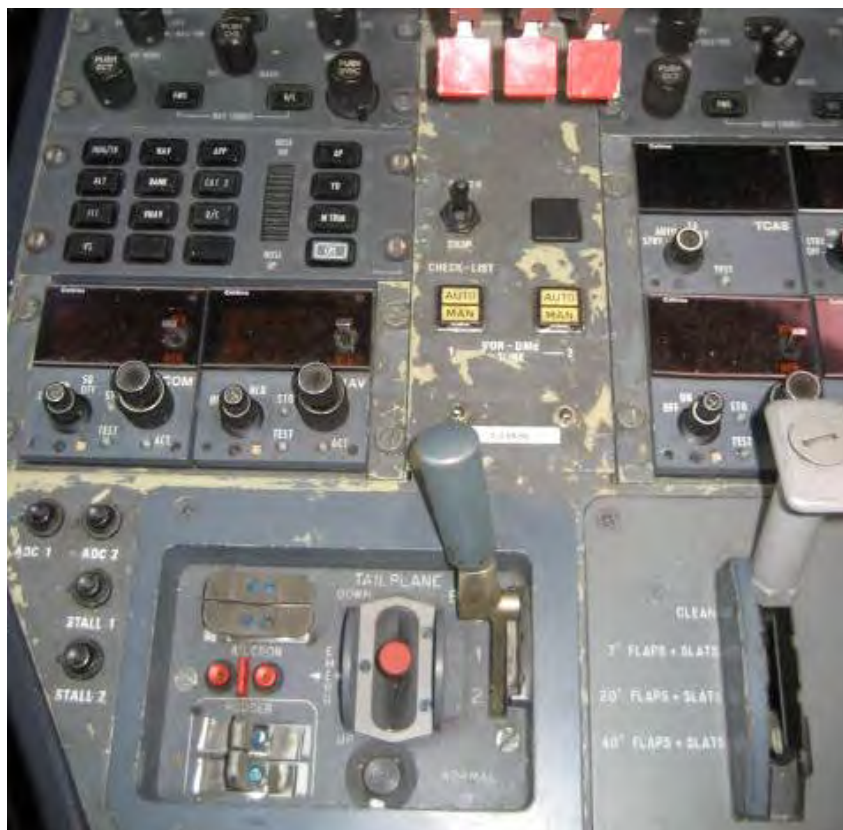
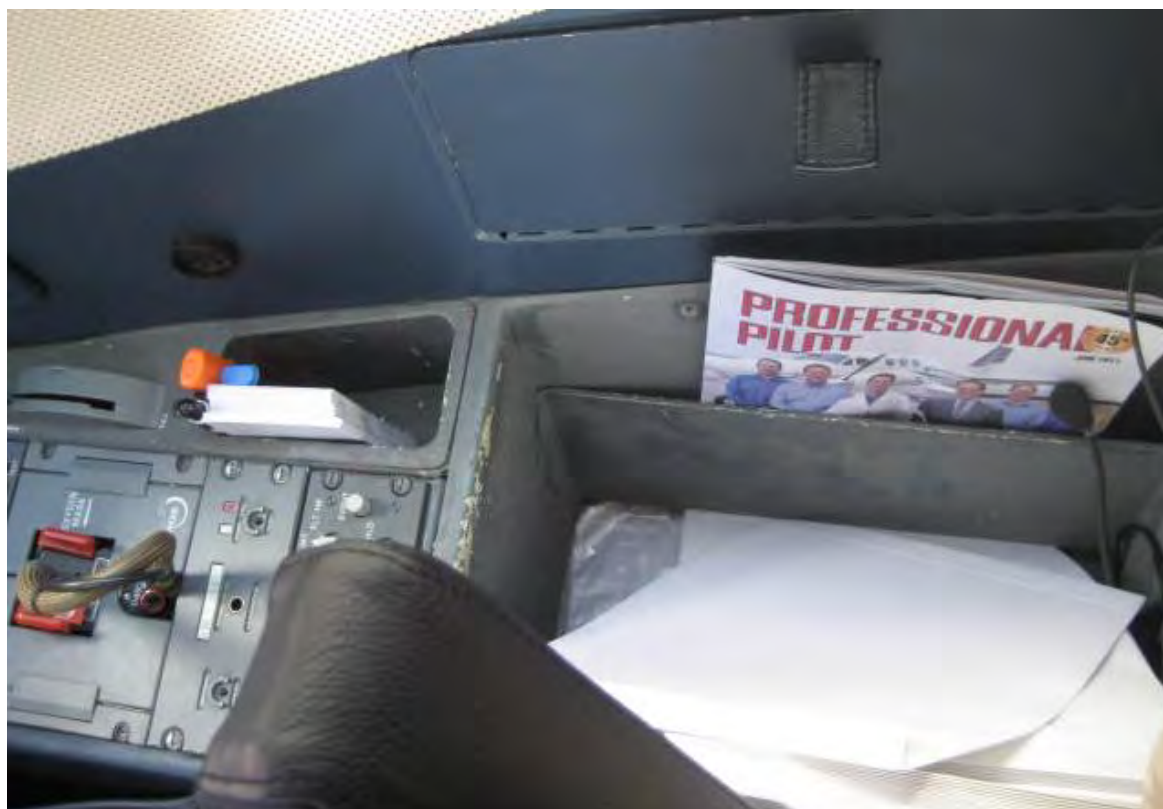
Damaged centre pedestal
