## → Aircraft Inspection Report

**BNP Paribas Leasing Solutions N.V.**

Aircraft Type: Mystere-Falcon

Aircraft Registration: PH-LCG

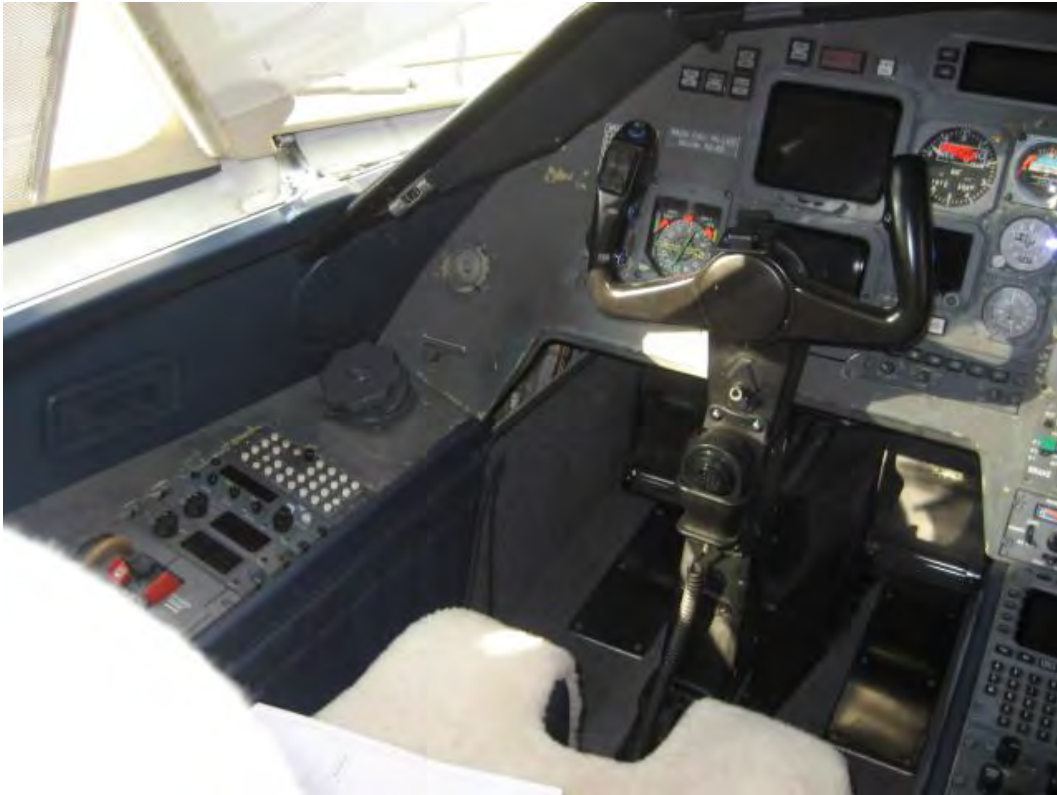
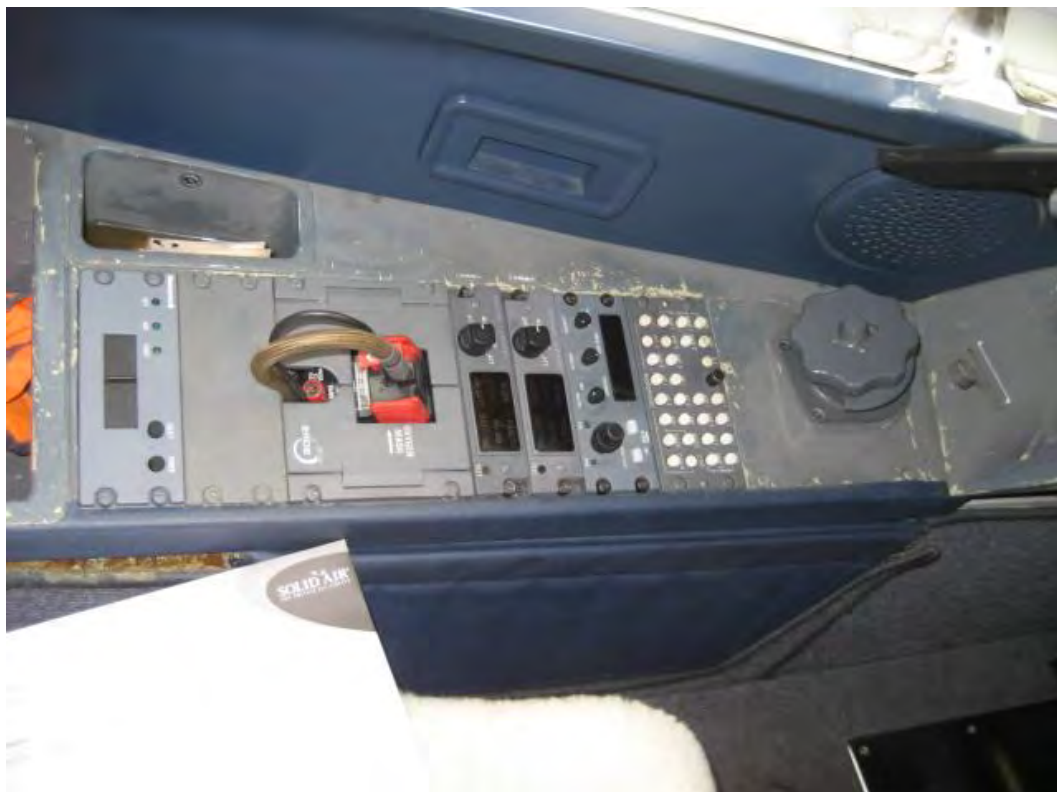
The instrument panels and placards and markings are old and worn. The centre pedestal has heavy nicks and scratches (see pictures).

Worn instrument panels

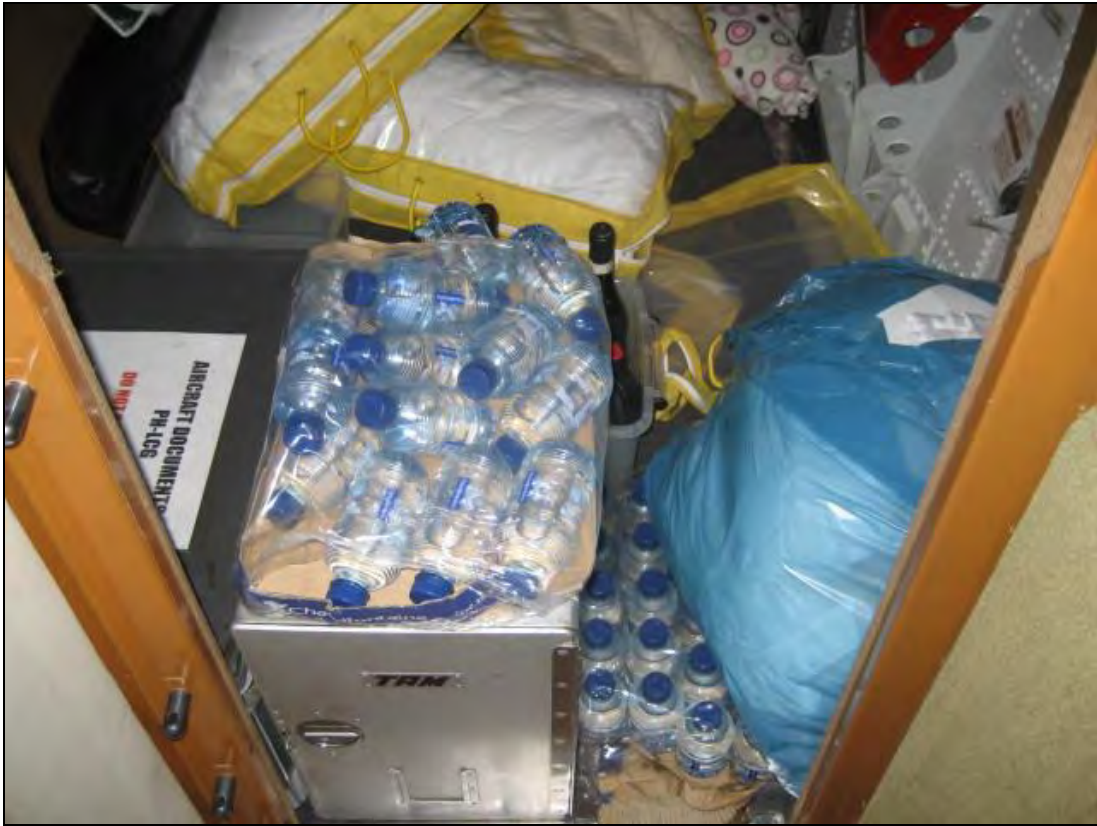
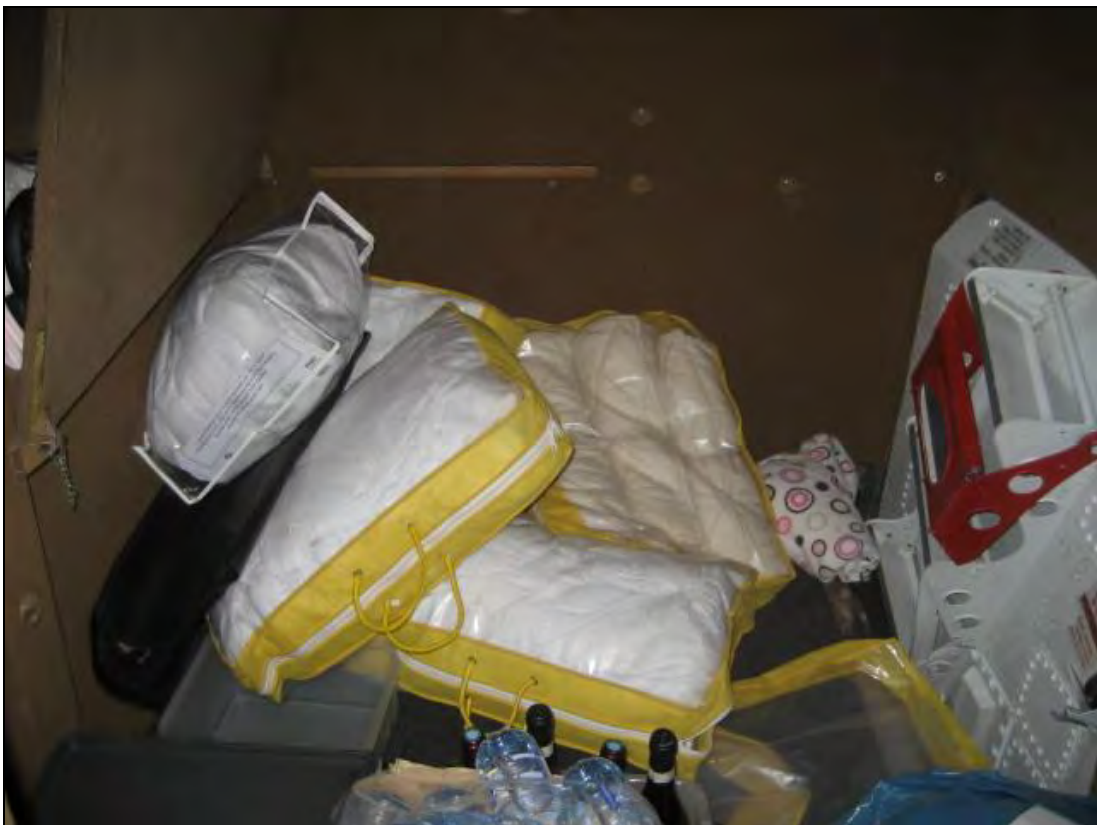
The cargo / baggage compartment is in an AVERAGE condition.

A cargo net was not found.
