## → Aircraft Inspection Report

**BNP Paribas Leasing Solutions N.V.**

Aircraft Type: Mystere-Falcon

Aircraft Registration: PH-LCG

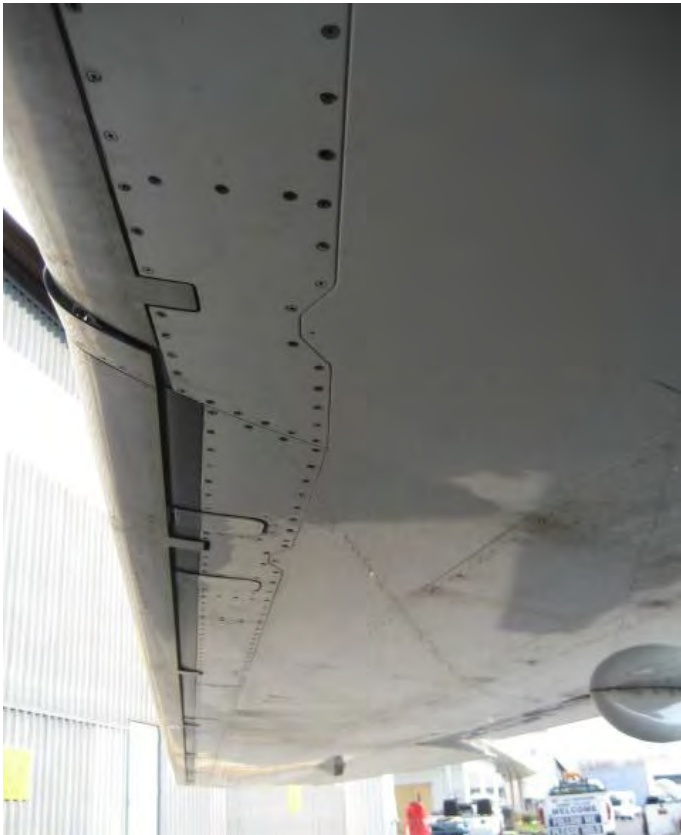
The right wing has evidence of a fuel leak and a hydraulic leak

- the fuel and hydraulic leaks on the right wing
- the shade on the emergency exit hatch
- refurbish the Captain's and First Officer's seat belts and the First Observer's seat

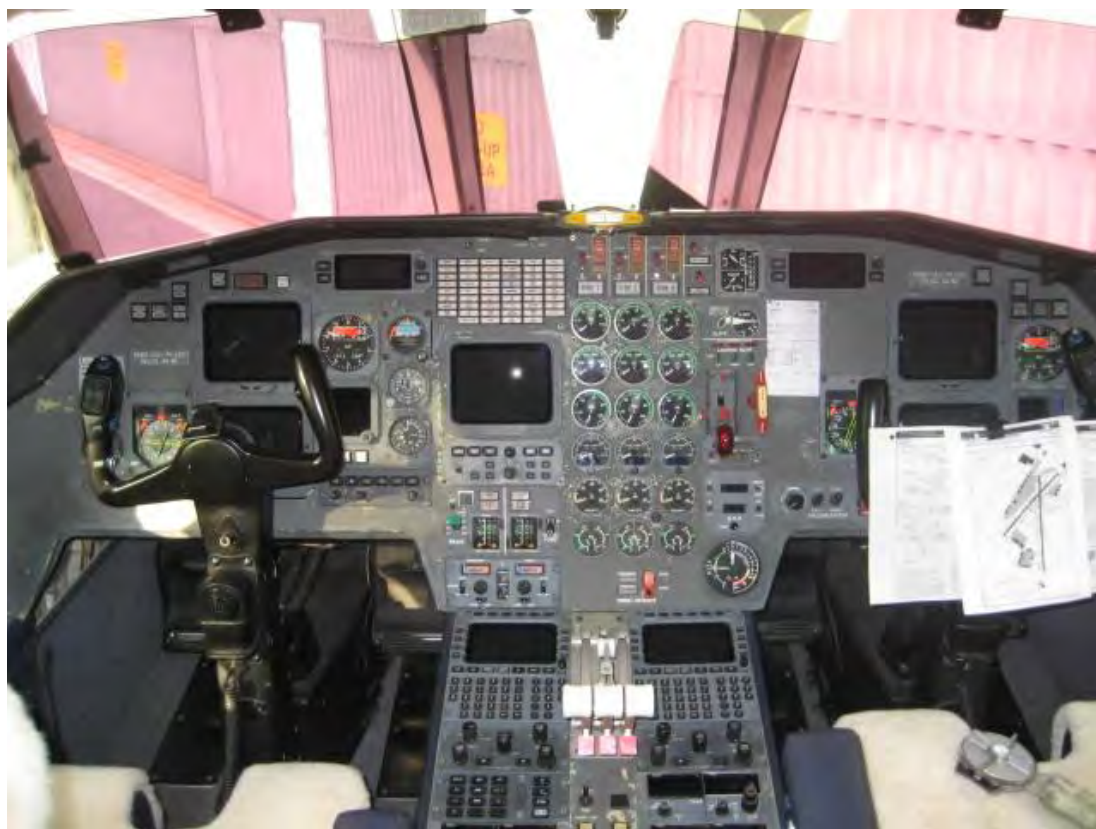
Damaged centre pedestal

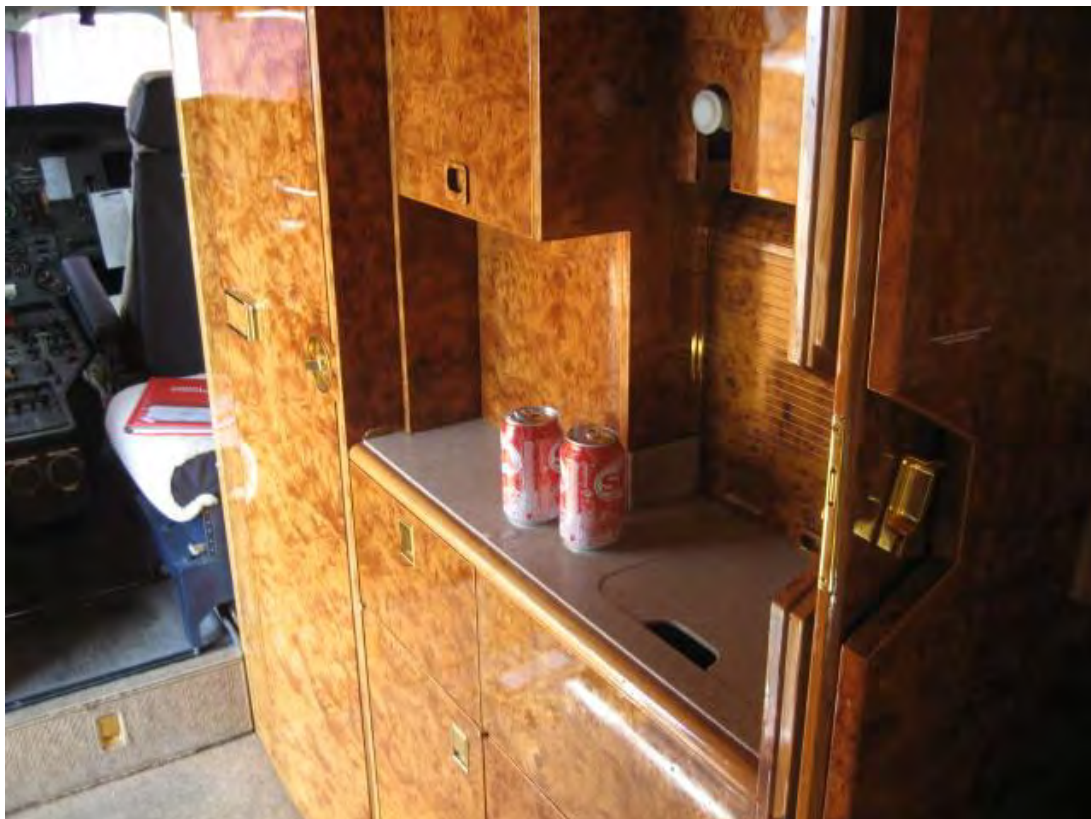
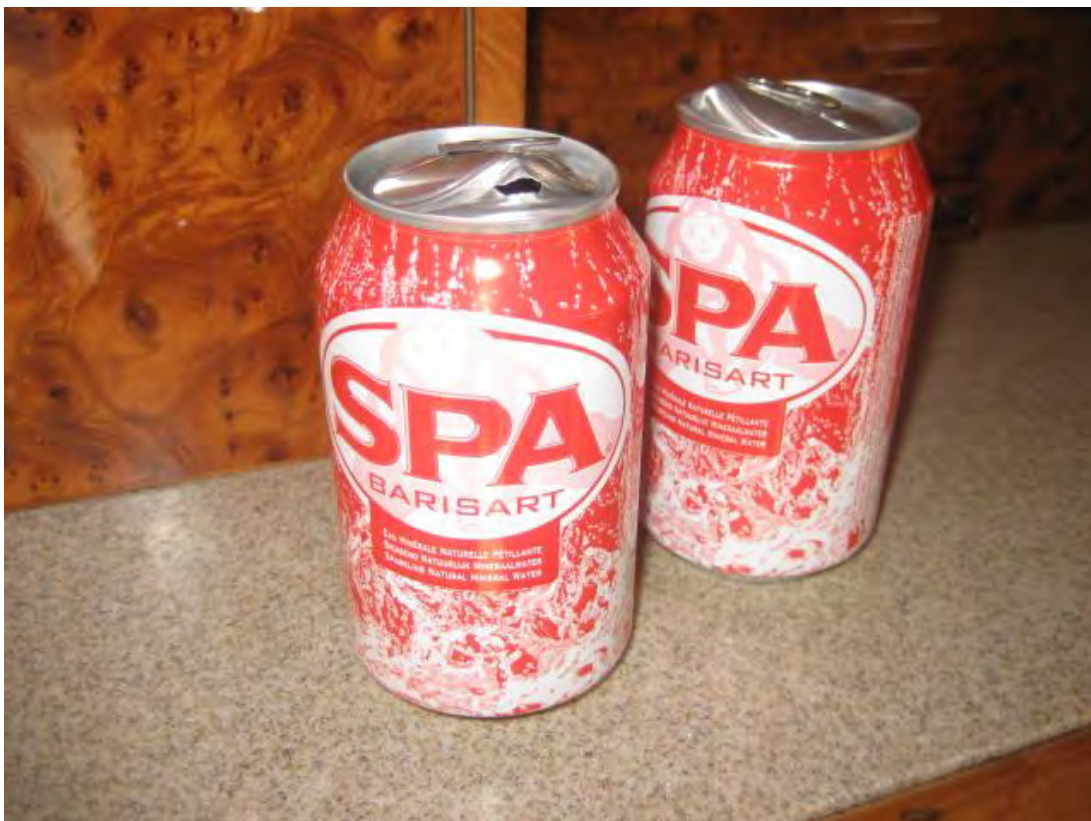
Several burst soda/water cans were found in the galley which would indicate a high probability that the water system plumbing in the galley, and the lavatories, have also ruptured due to freezing. If the lavatory/galley plumbing has ruptured due to freezing temperatures in TEB during the 2011 and 2012 winters. There is a high probability that water has leaked into the fuselage belly under the cabin and galley floor.

Burst soda cans

Areas which have been heavily oxidised should be polished and a detailed inspection of the engines and fuselage belly should be carried out to determine the extent of the corrosion. An inspection of the lavatory/galley plumbing should be carried out to see if it has ruptured due to freezing. The manufacturer will need to be contacted in order to find out how the aircraft can be brought back into an airworthy condition. However, before the manufacturer is contacted the missing documents need to either be obtained and reviewed or rebuilt.

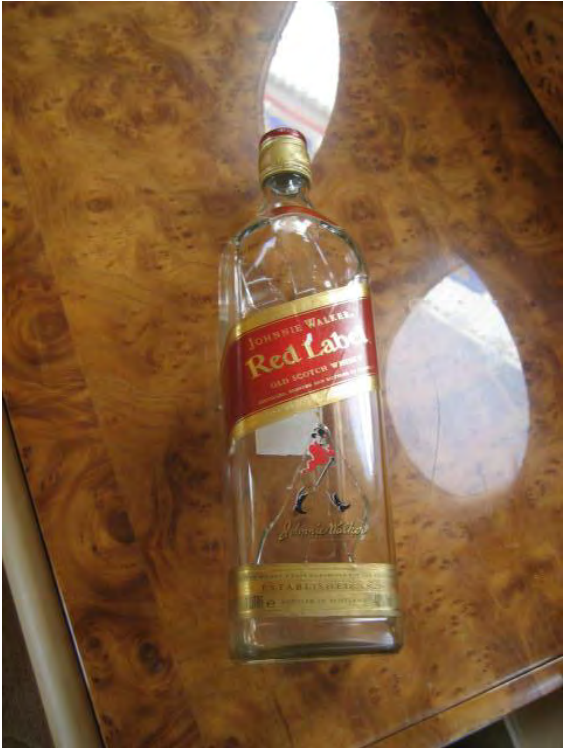
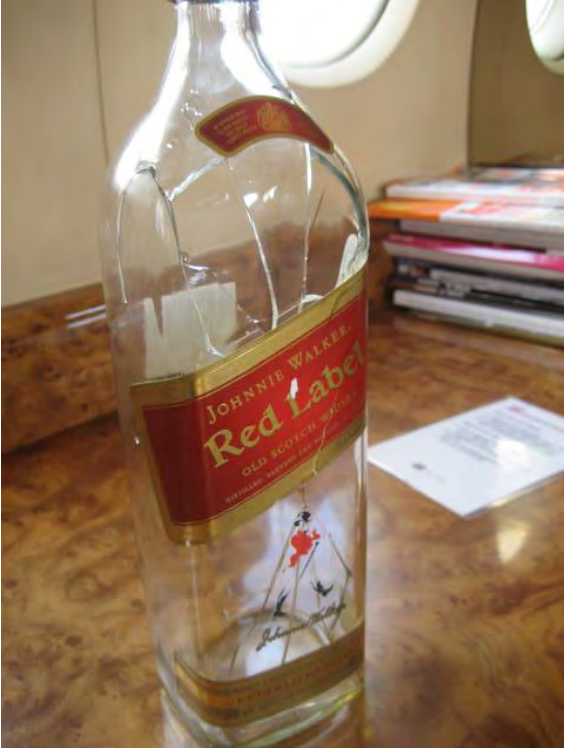
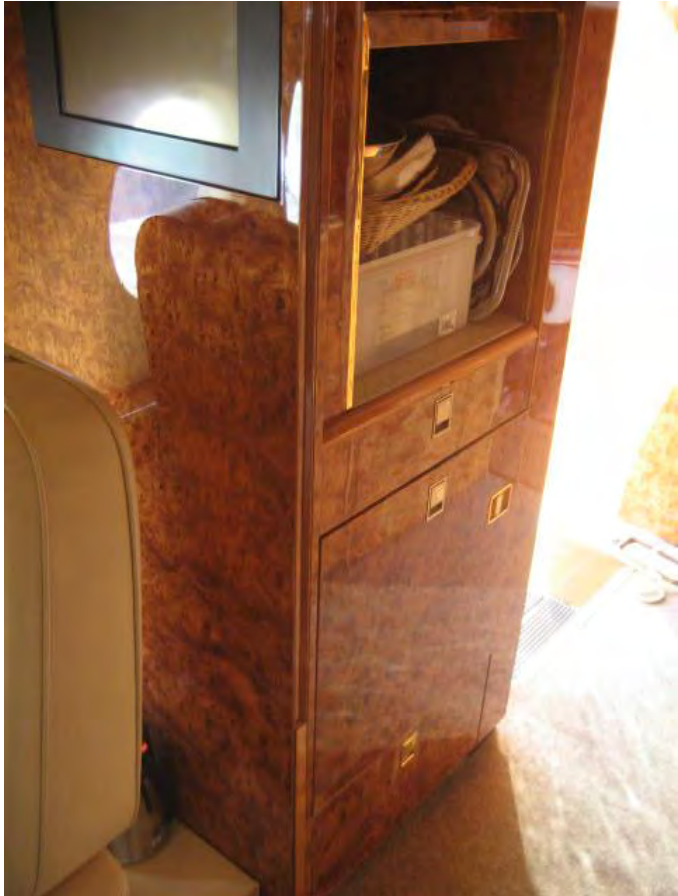
Burst bottle
