## → Aircraft Inspection Report

**BNP Paribas Leasing Solutions N.V.**

Aircraft Type: Mystere-Falcon

Aircraft Registration: PH-LCG

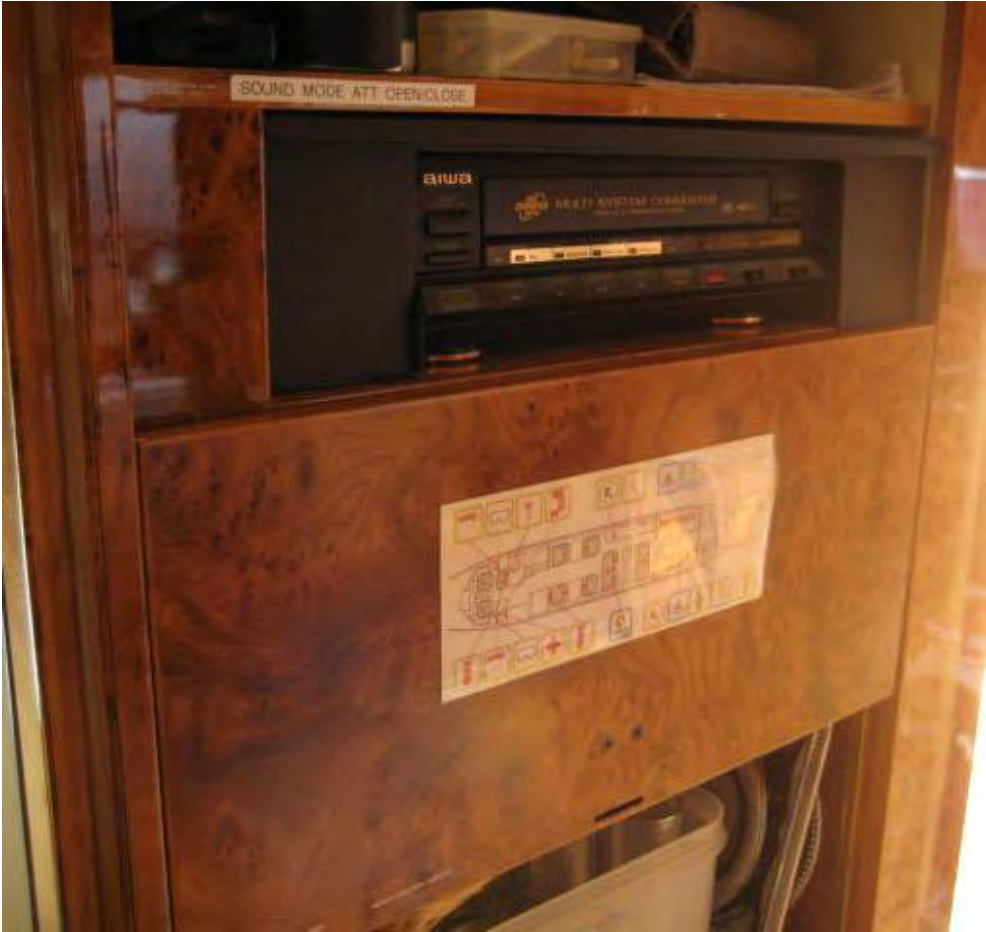
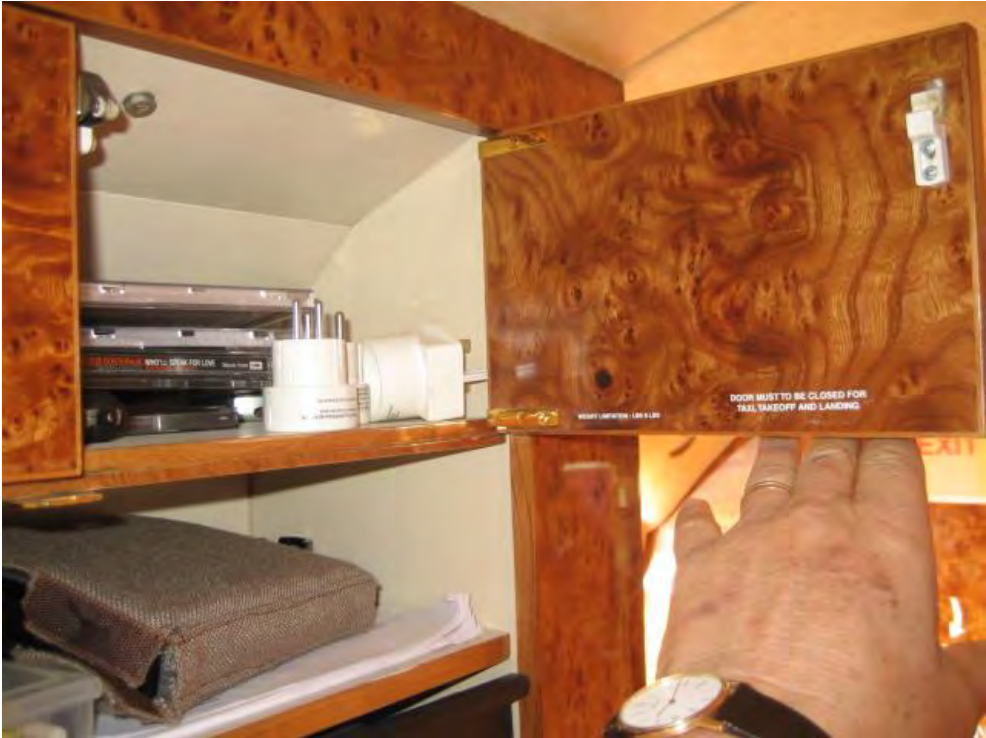
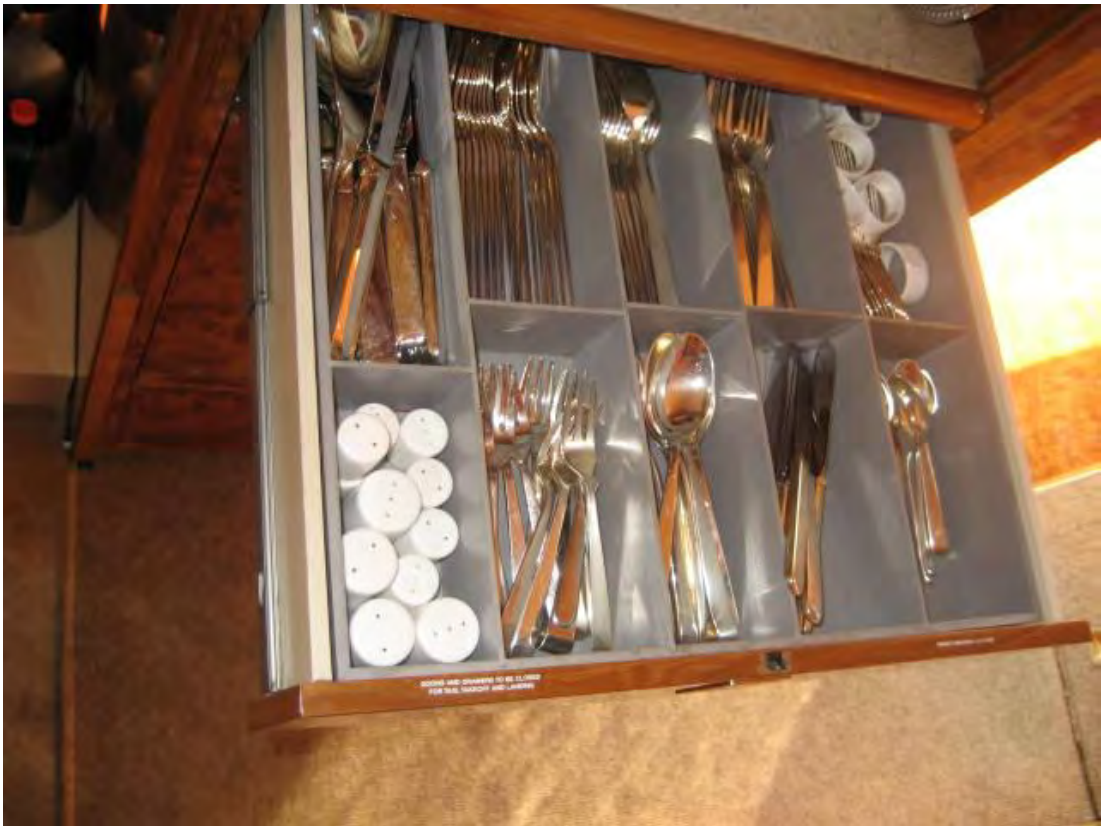
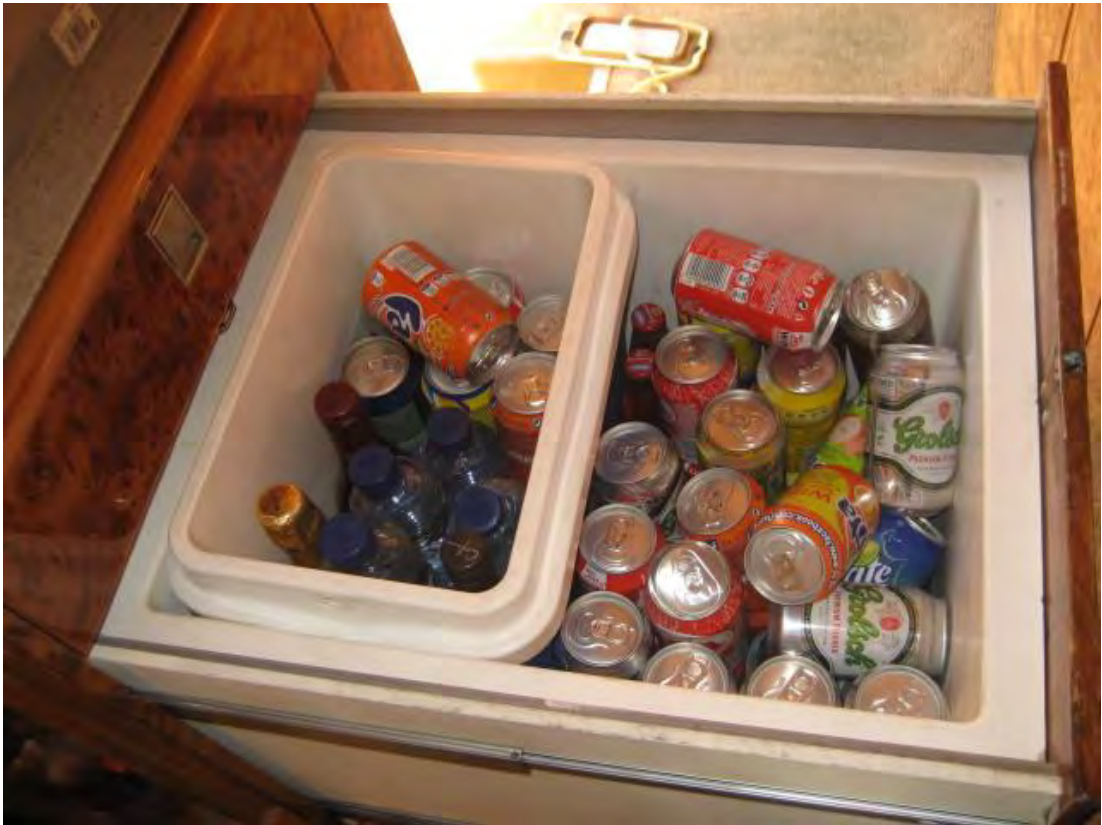
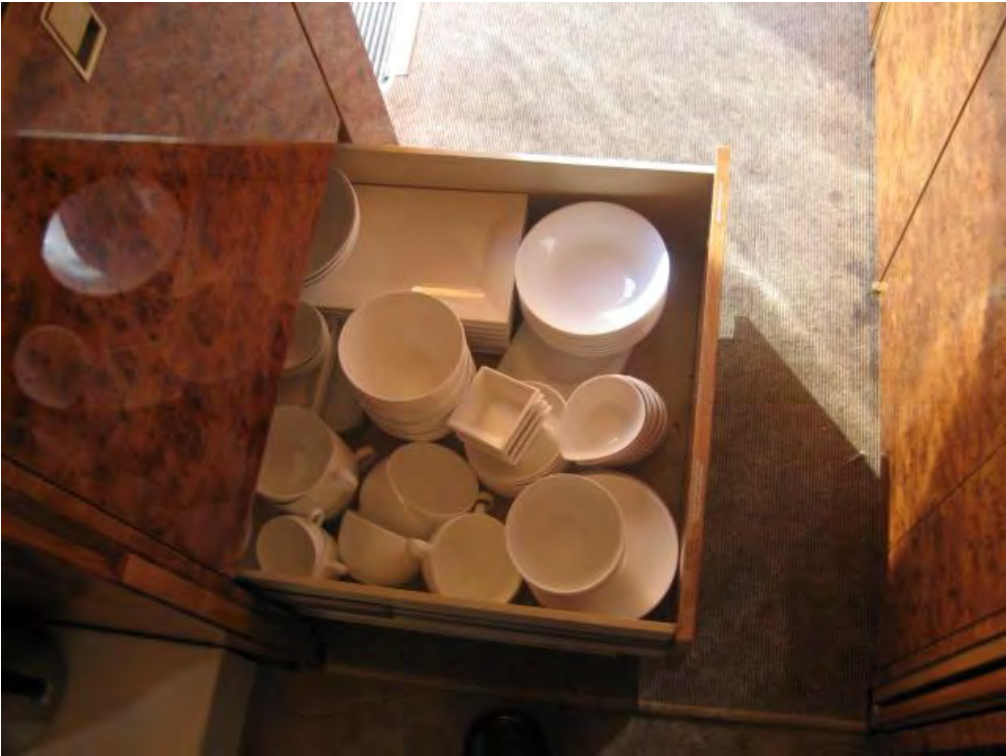
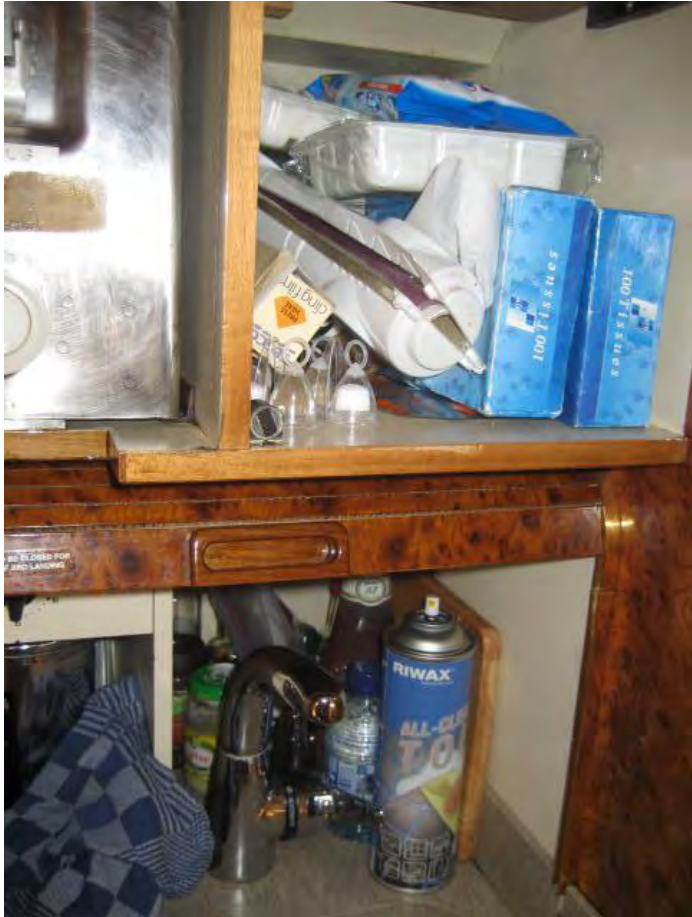
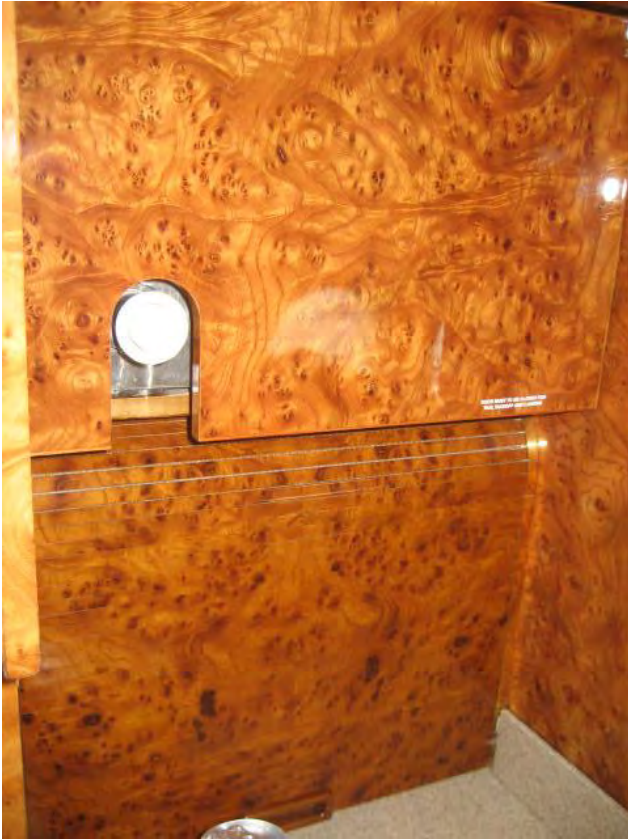
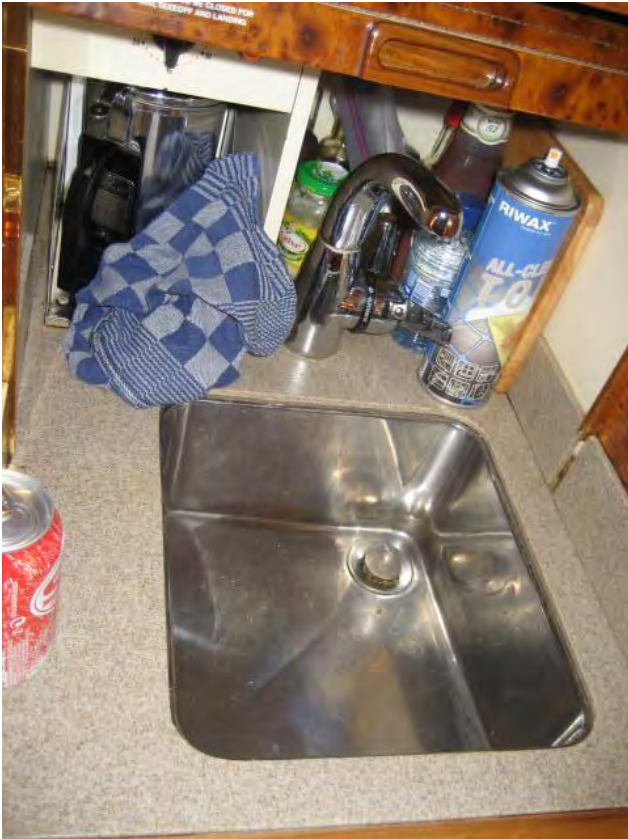
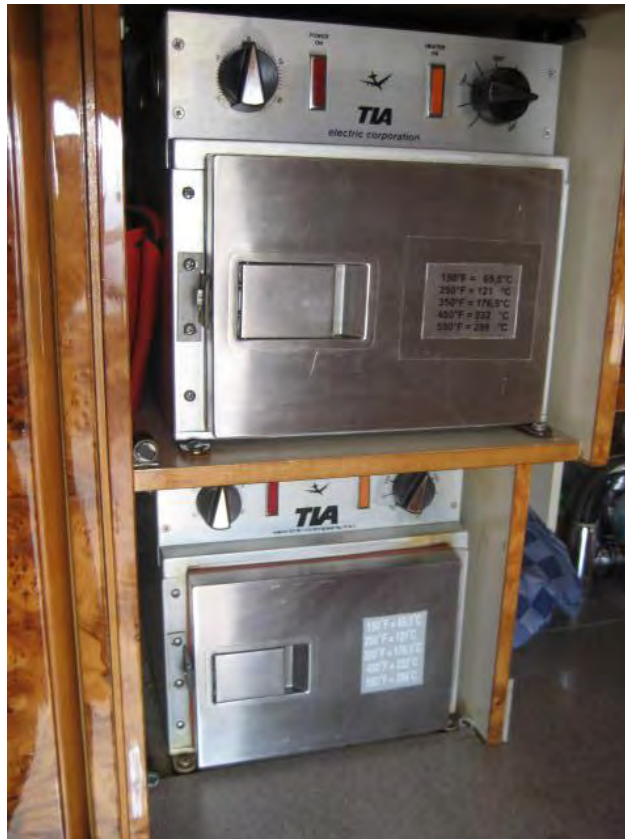
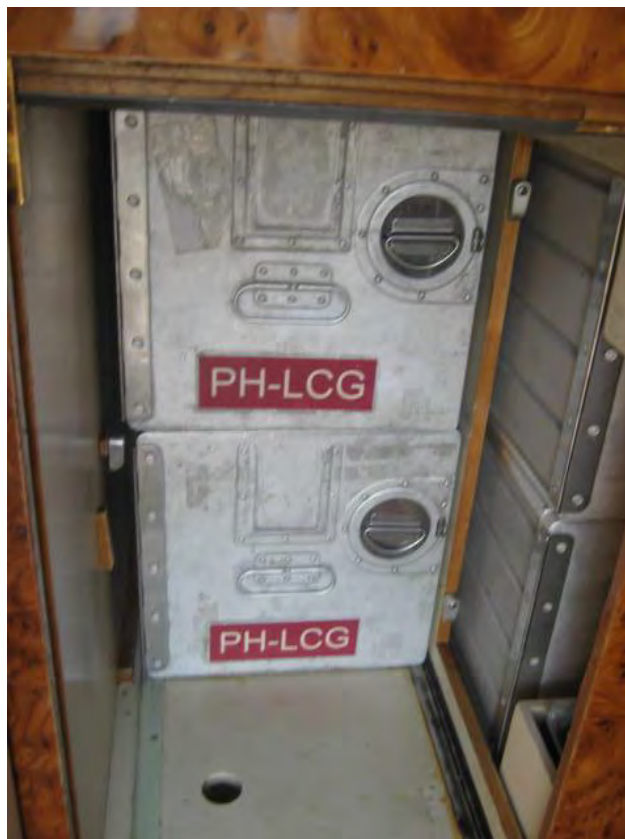
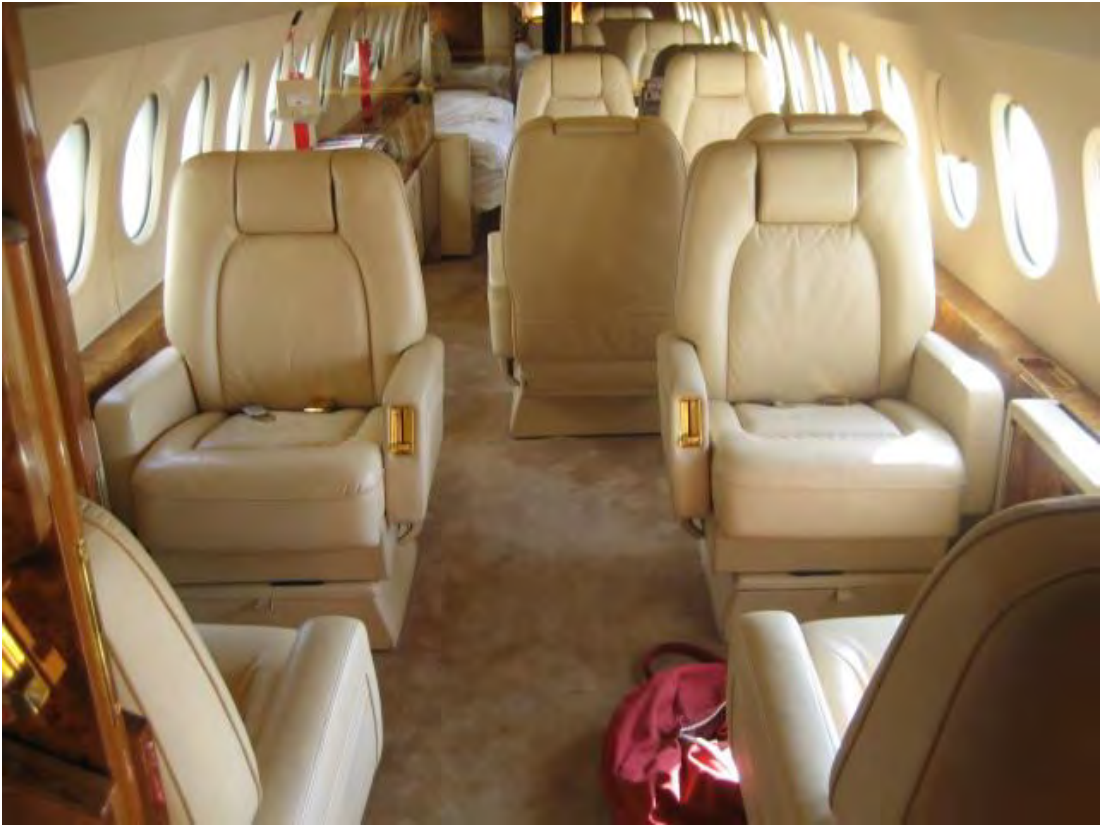
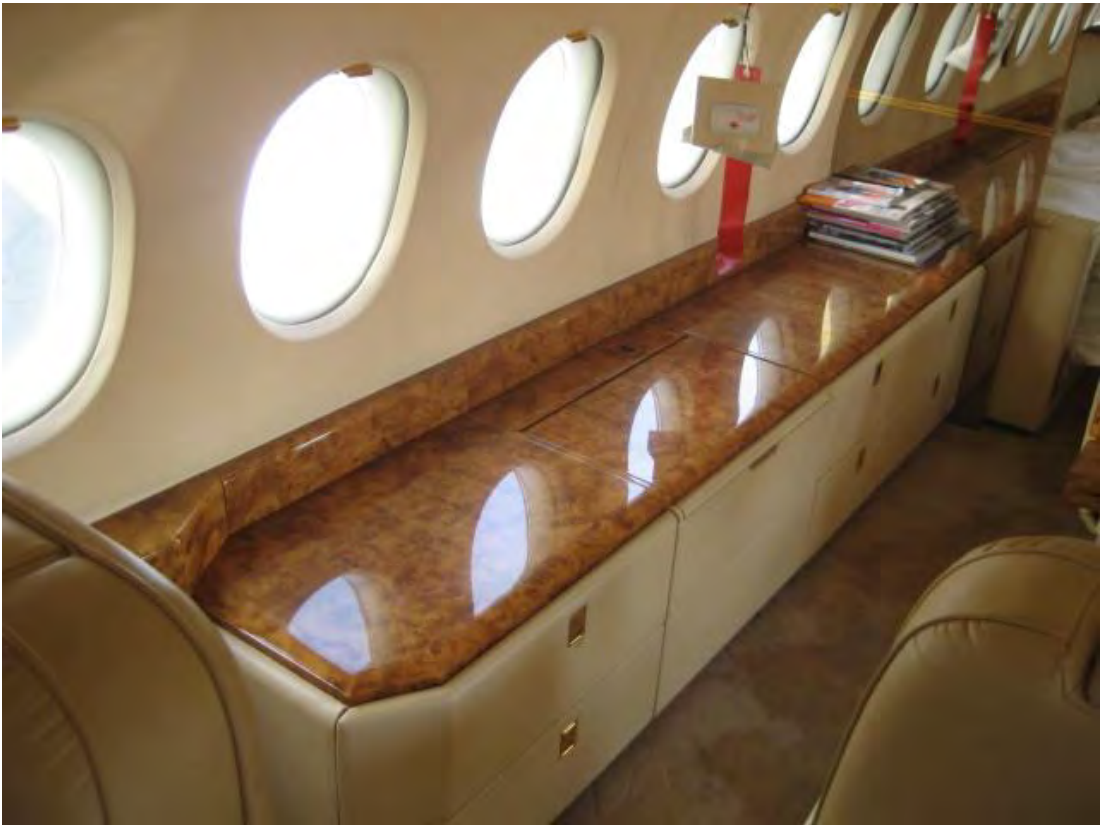
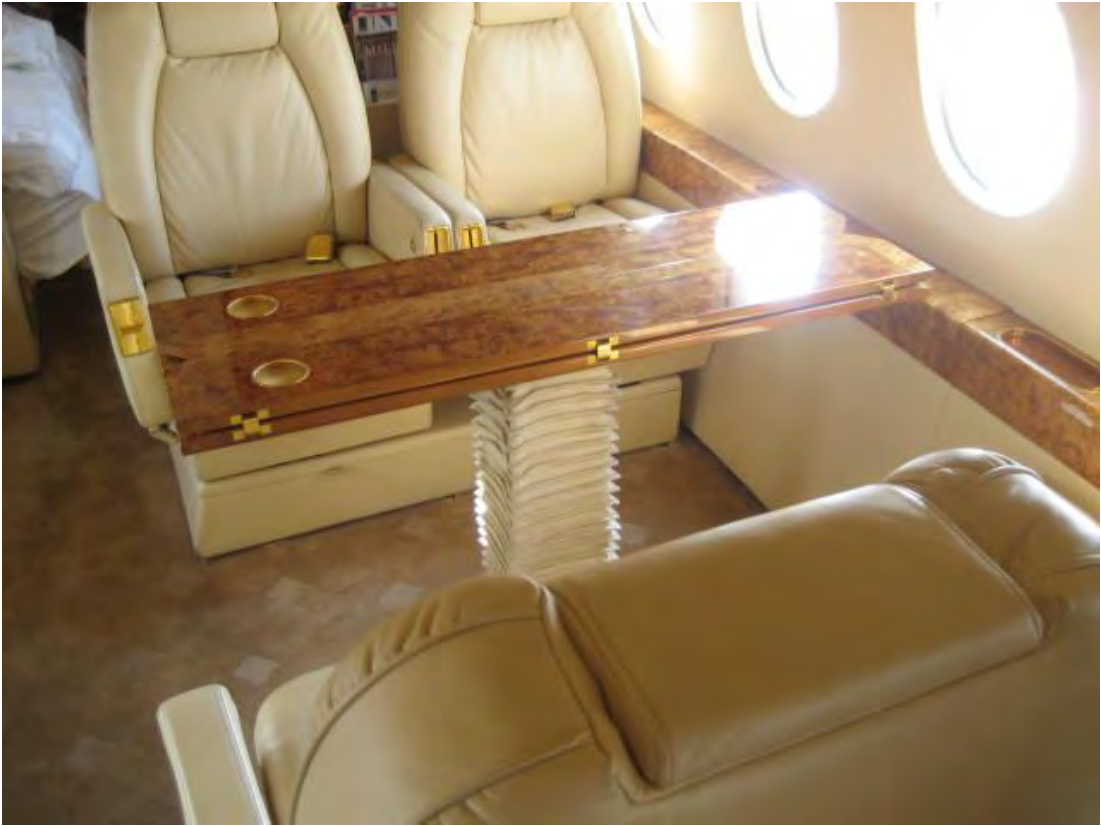
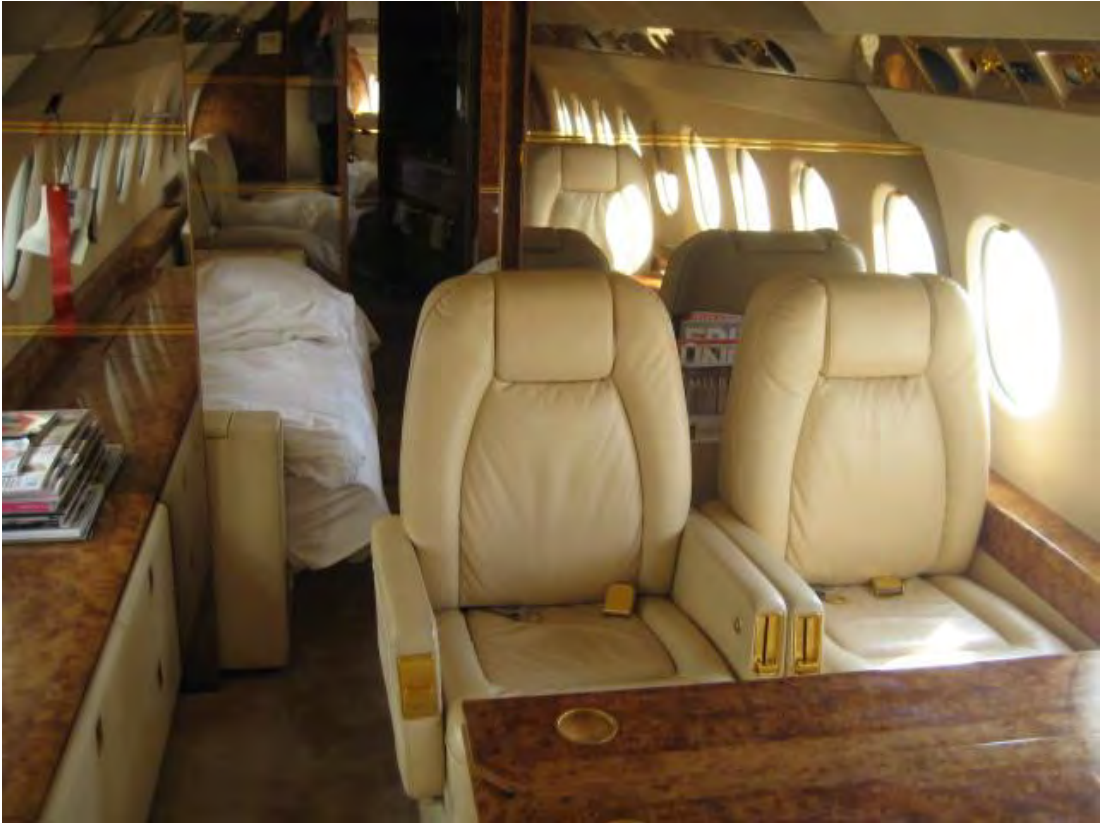
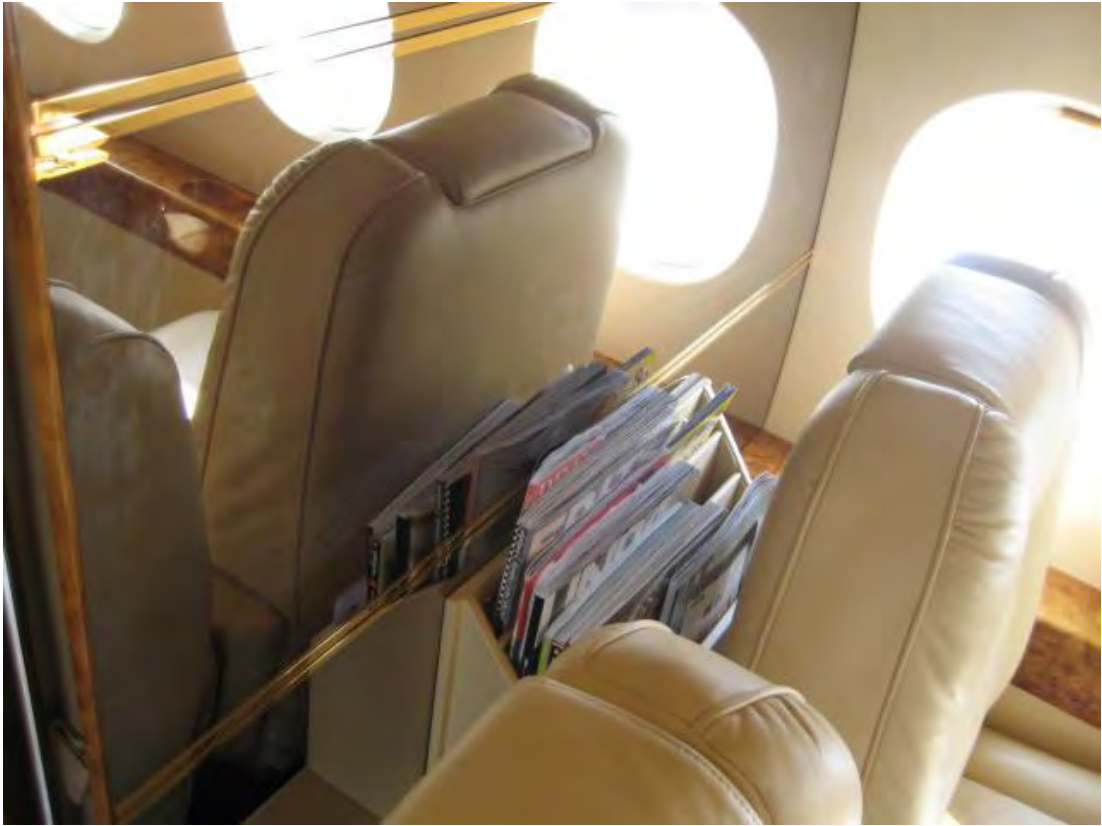
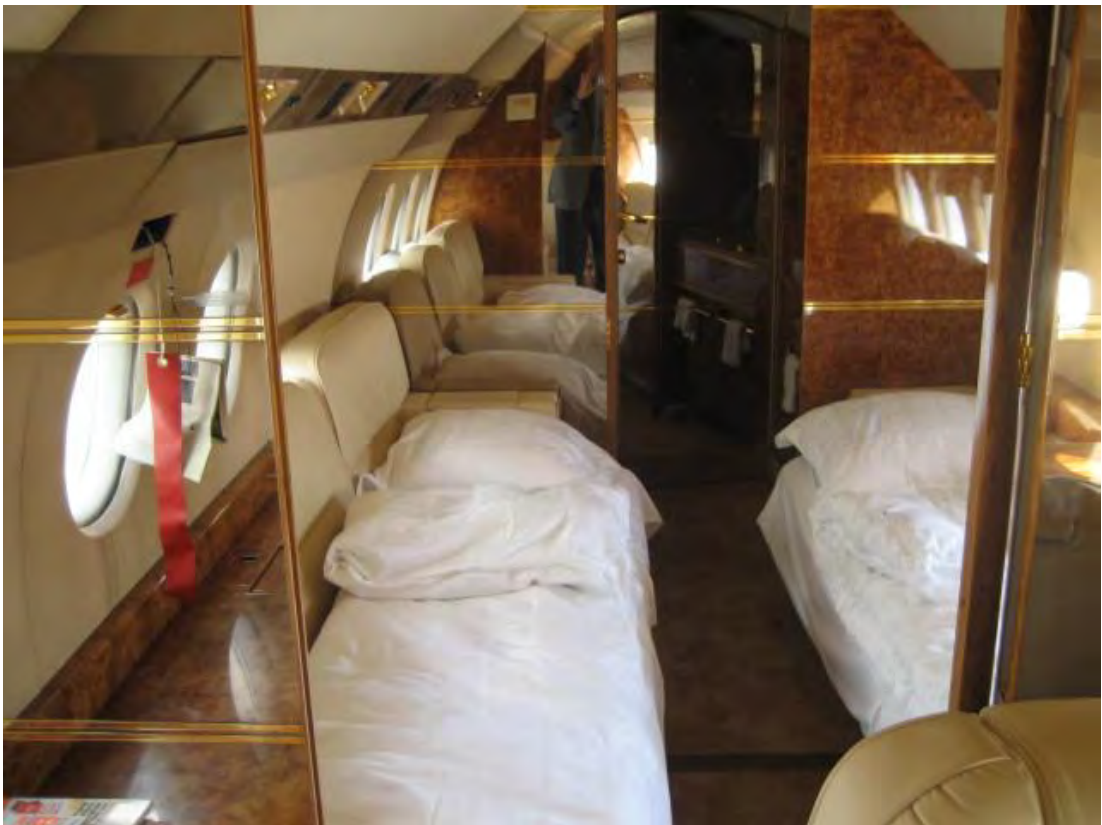
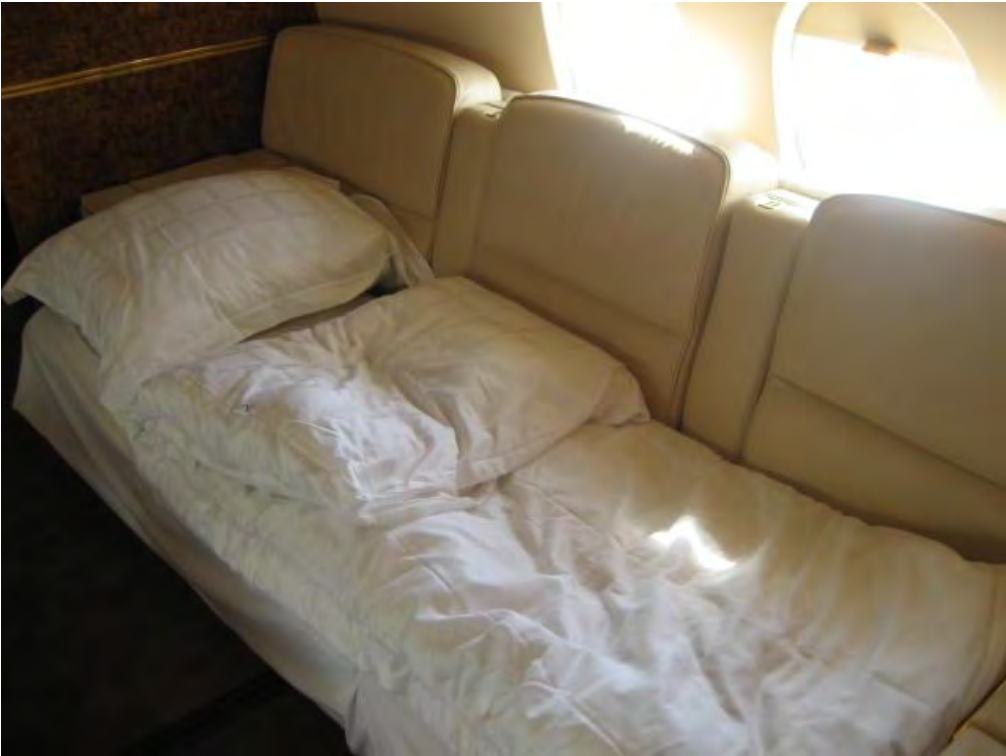
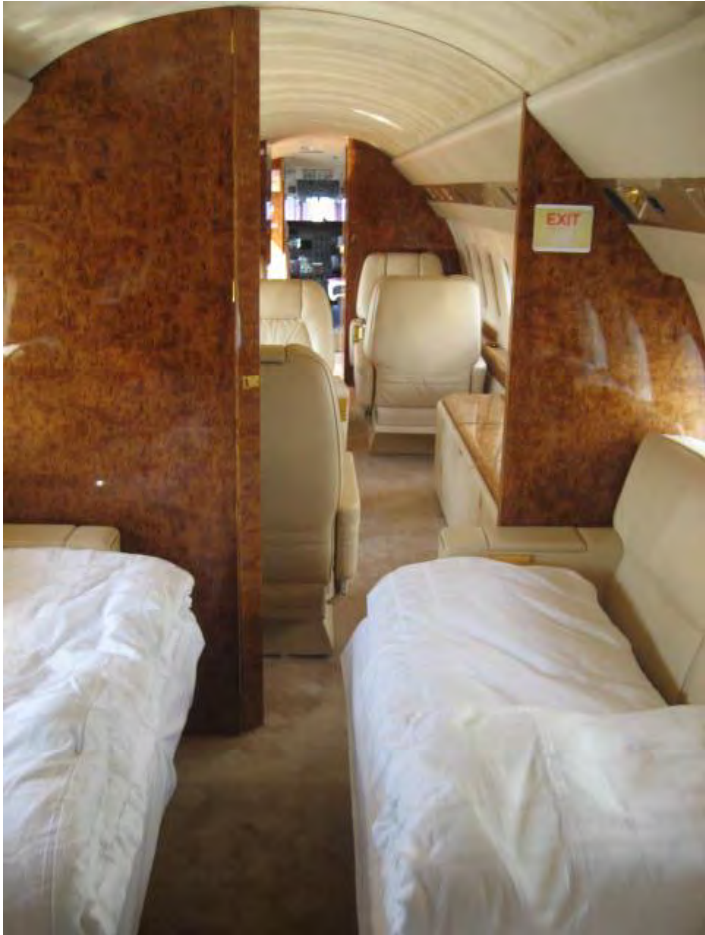
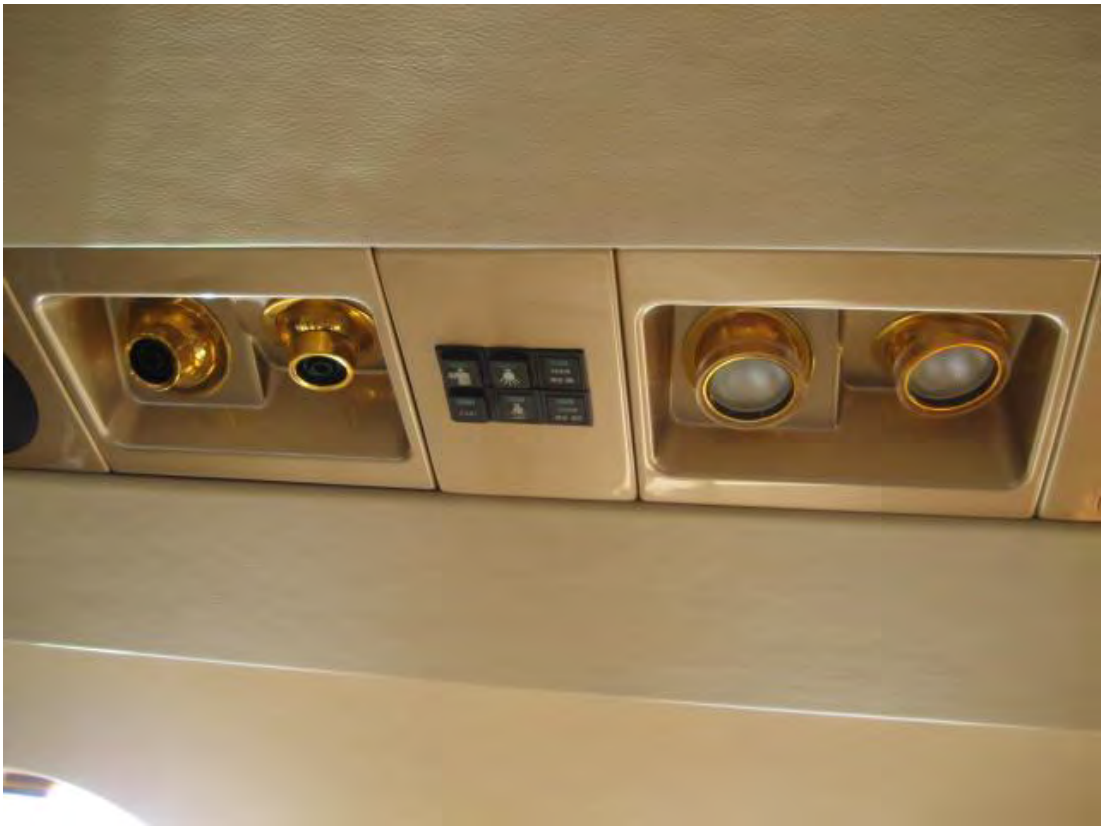
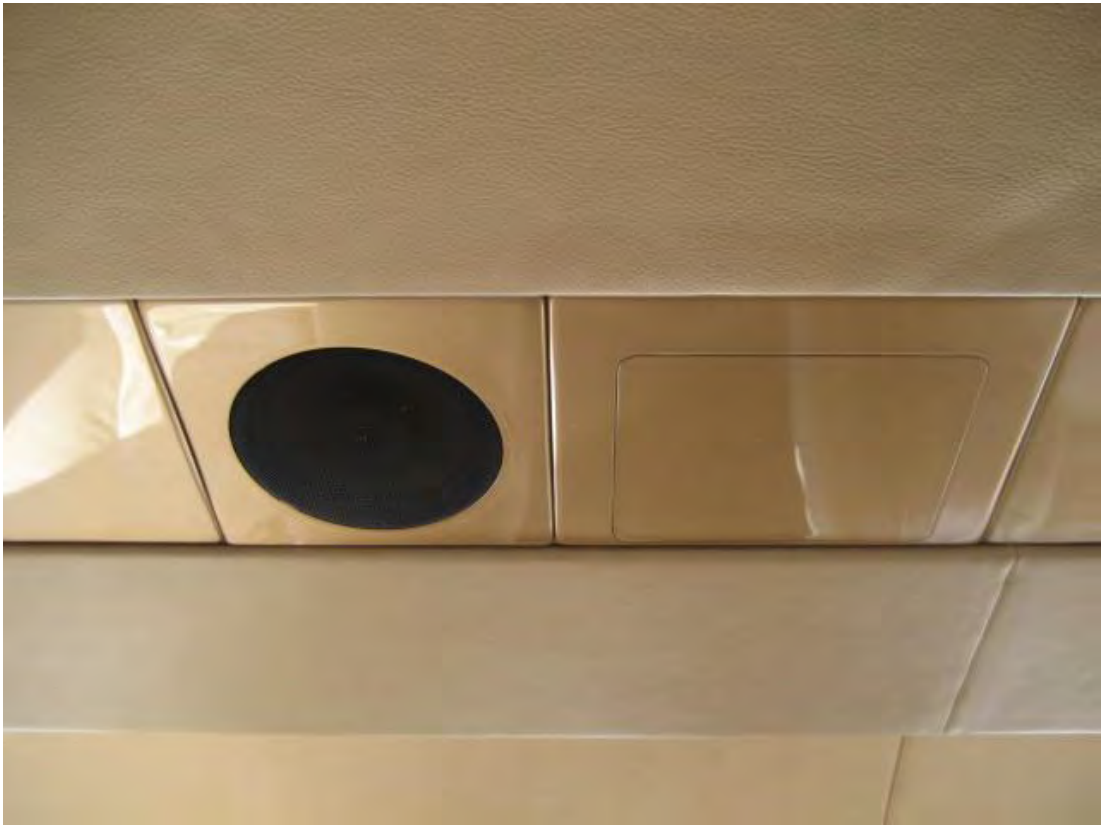
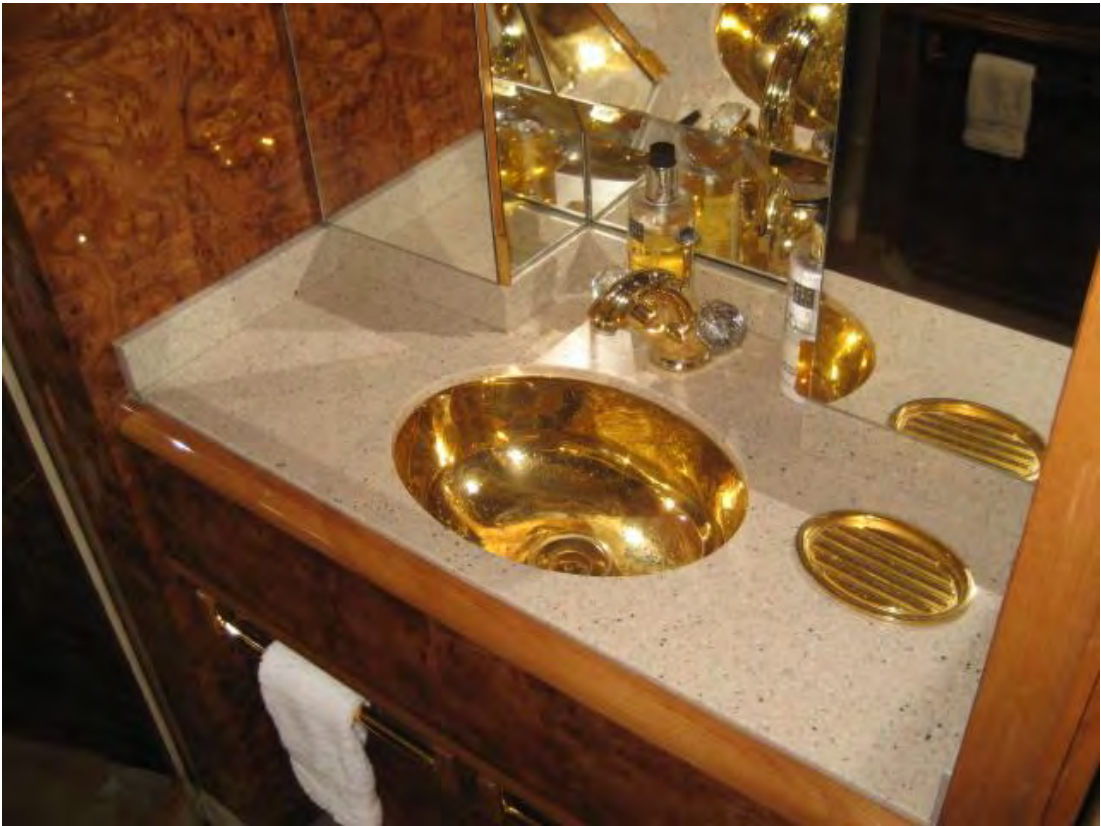
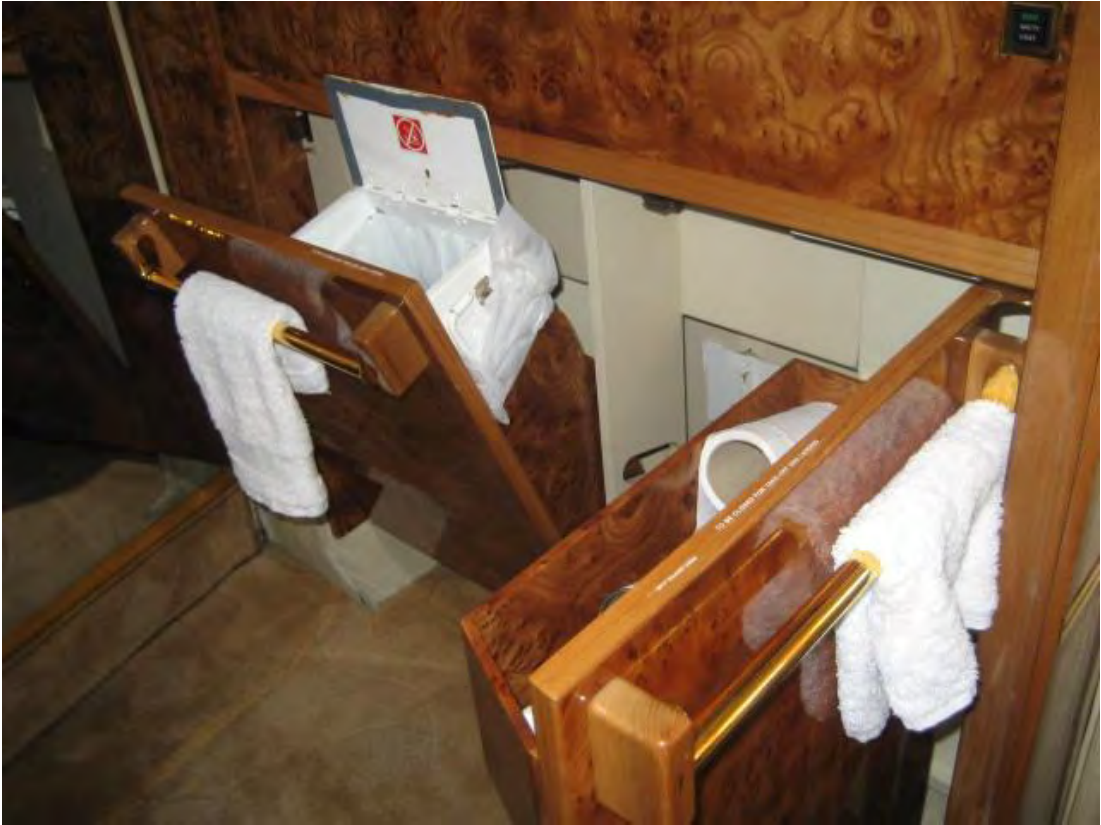
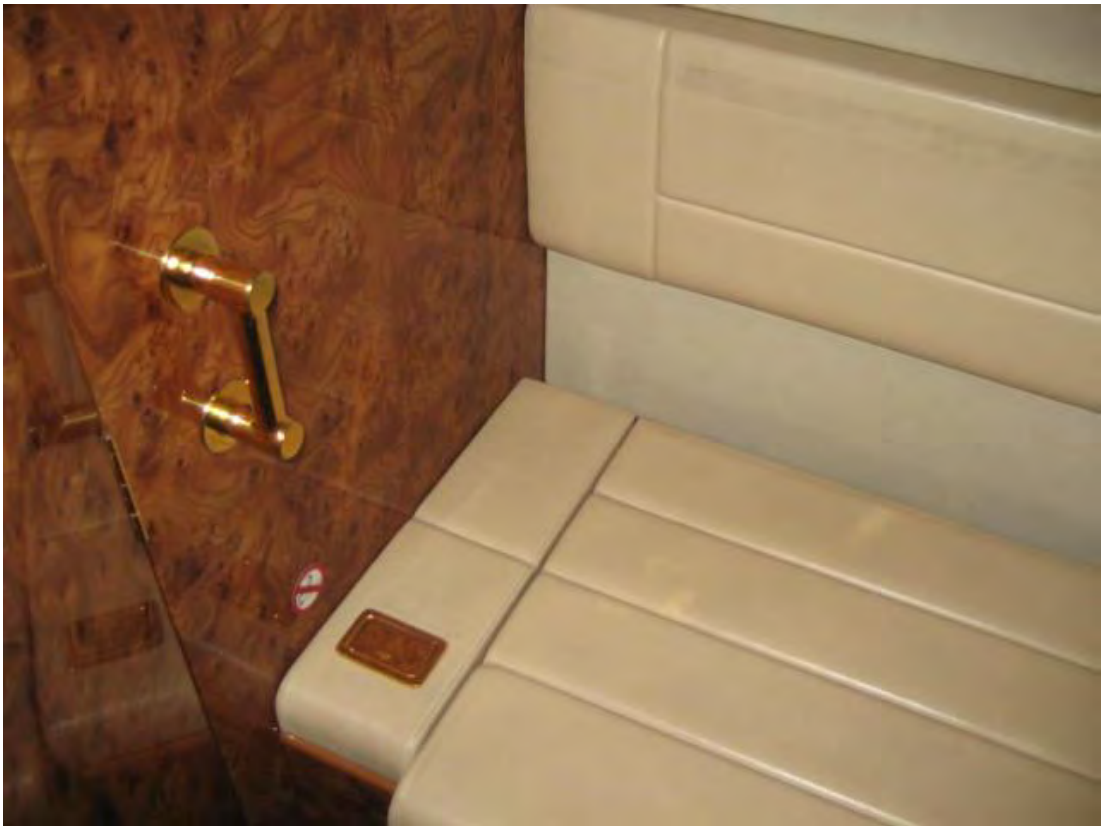
The cabin interior is in an AVERAGE condition.

Several burst soda and water cans were observed in the stowage bins. It is very likely that the burst water and soda cans leaked water and soda under the cabin and galley floor. The toilets may have also suffered cracking from the freezing temperatures in TEB during the 2011 & 2012 winters.
